## GEOBARRIER SYSTEM FOR USE IN UNDERGROUND STRUCTURE

# **GEOBARRIER SYSTEM FOR USE IN UNDERGROUND STRUCTURE**

*Research Collaboration between:*

**Nanyang Technological University  
Housing & Development Board**

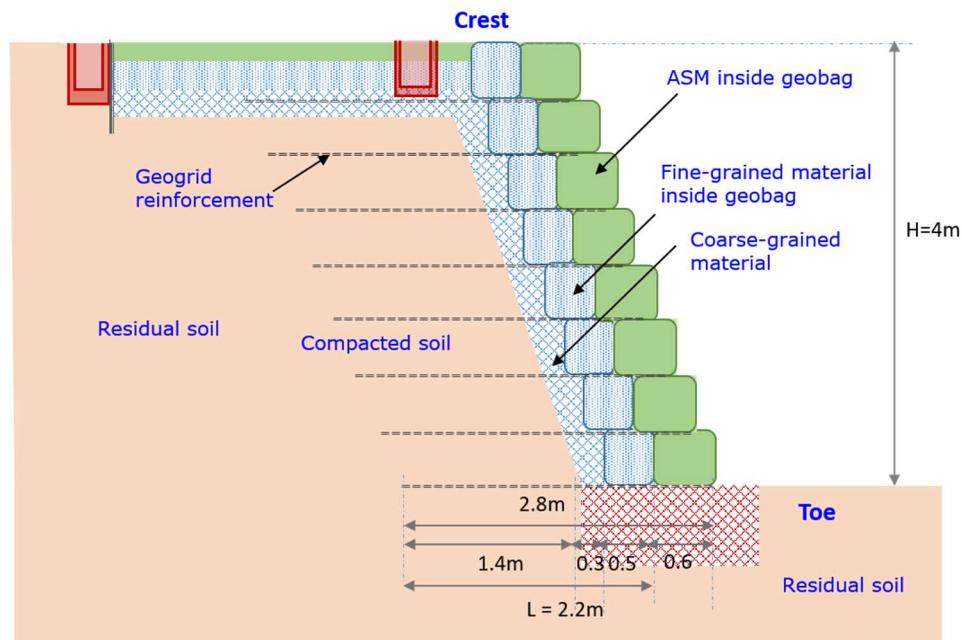
Figure 1: Schematic diagram of Geobarrier system (GBS)

Previous studies by [Rahardjo et al. \(2013\)](#) and [McCulloch et al. \(2017\)](#) showed that recycled materials can be used to replace natural materials forming the capillary barrier system. Therefore, in line with current sustainable environment policies, recycled materials were used as components of capillary barrier system in the GBS. Approved soil mixture (ASM) was also contained in geobag and placed in front of the fine-grained layer to facilitate the planting of deep and widespread rooted shrubs/trees. The reinforced fill is made of compacted residual soil. The system was also enhanced with proper drainage system through gravel sump below the toe of the slope. The sump is located at the bottom of the GBS slope to collect the rainwater from fine-grained layer and drain it out to main drainage. The cross-sectional view of GBS is shown in [Figure 1](#).

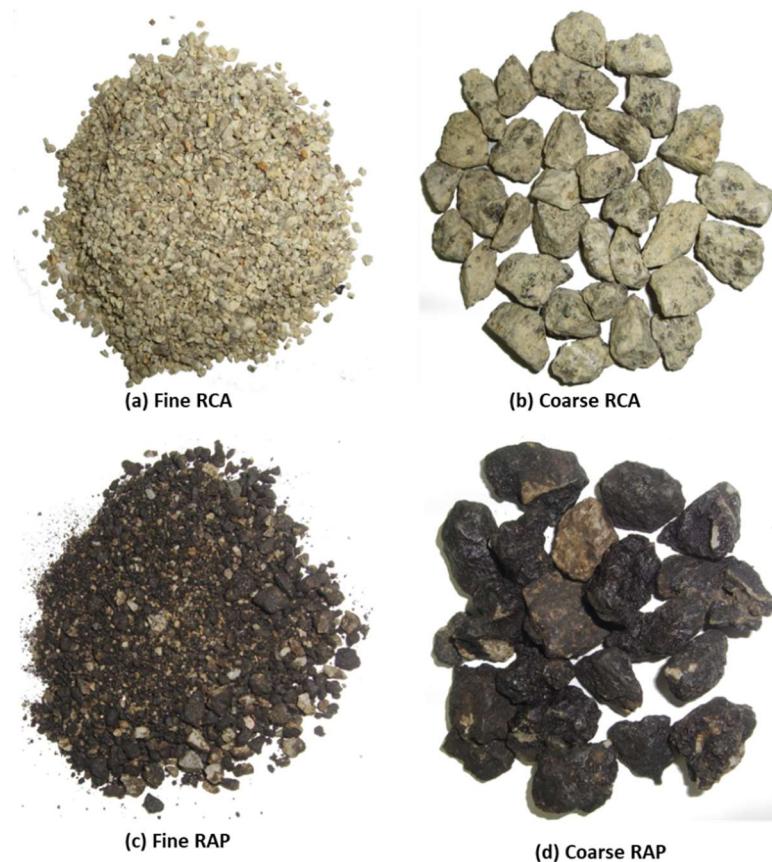
**Figure 2. RCA and RAP used for construction of GBS at Pilot study site**

Recycled concrete aggregates (RCA) and reclaimed asphalt pavement (RAP) were used for the construction of GBS. The fine-grained material (fine RCA or fine RAP) was wrapped in a geobag and stacked on top of each other on the wall face to form a retaining wall. Coarse RCA or coarse RAP was placed behind the geobags to limit water infiltration into the compacted residual soil. The materials used for the construction of the GBS were selected in such a way that the system will not cause any adverse effect to the environment. Toxicity characteristic leaching procedure (TCLP) were conducted on the RCA and RAP to ensure that the discharge from GBS will not cause contamination. The test results showed that both RCA and RAP used in the Pilot study did not contain any hazardous chemical. The RCA and RAP used for the construction of GBS at the pilot study site are shown in [Figure 2](#).

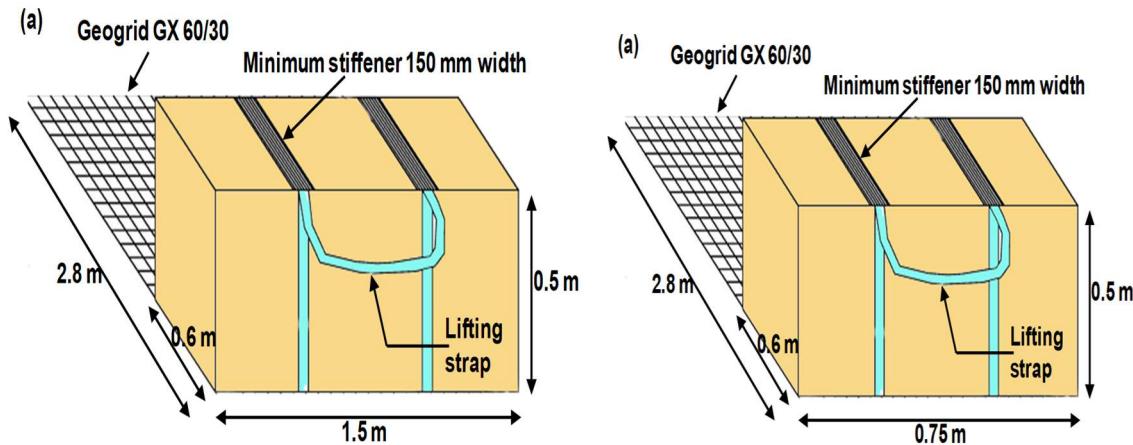
**Figure 3: Geotextile bags for (a) ASM and (b) fine grained material**

the vegetative cover for the GBS. The sizes of the openings were designed to be just large enough to accommodate the root balls of the plants.

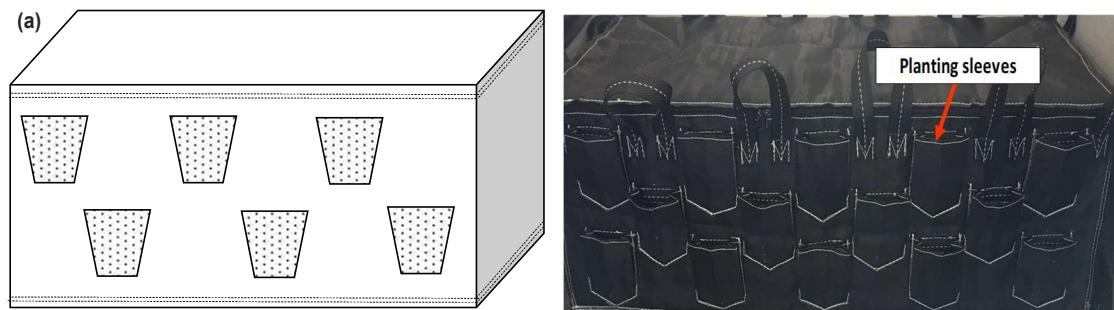
**Figure 4: Planting sleeves in front of ASM bags**

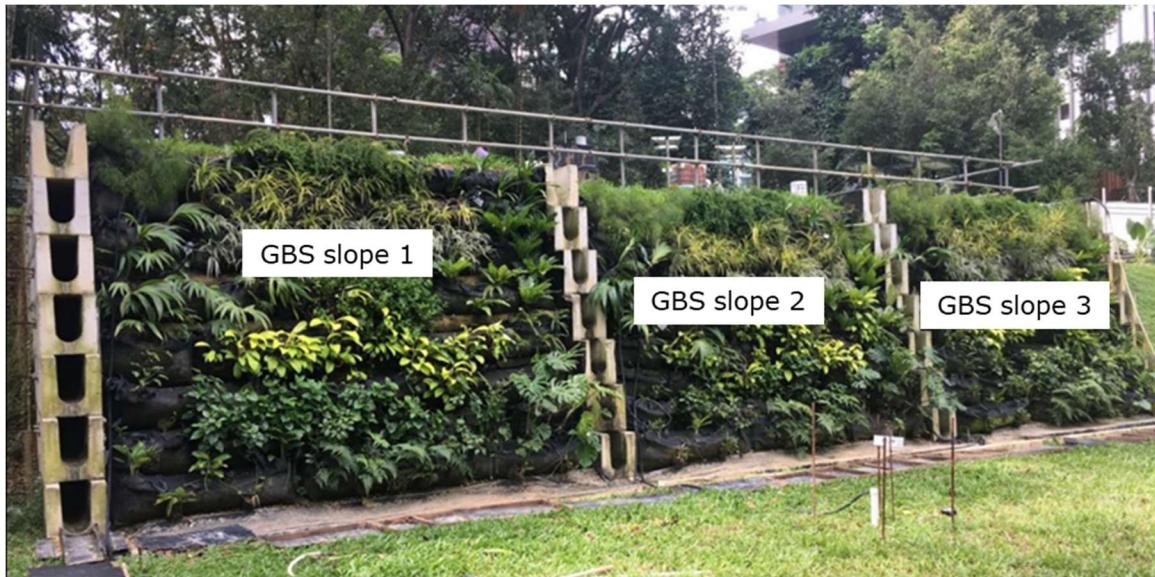
**Figure 5: Appearance of GBS with green cover**

The plants to be used as green cover in GBS are classified as deep rooted grass and small shrub. Deep-rooted grass need minimal irrigation, fertilizer or maintenance. Some of them grow quickly from seed while others are laid more successfully as sod. When deep-rooted grass grows well, they can reach 150–400 mm high and 150–400 mm diameter. The number of plants per 1 square meter is 14–5. There are many varieties of deep-rooted grass and small shrub, however the species of plants are suggested for the green cover of the GBS are shown in Table 2. The appearance of a completed GBS system with green cover is shown in [Figure 5](#).

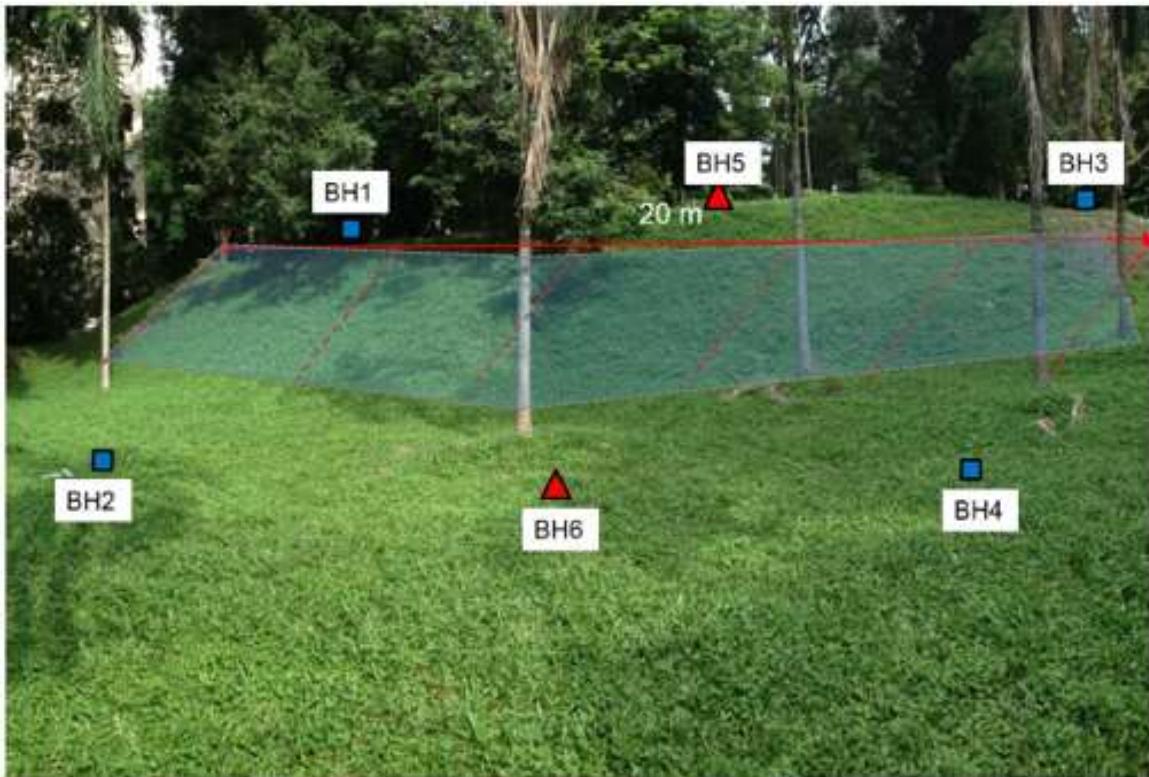
**Figure 7: Original slope condition and borehole locations at Pilot study site**

the soil. The boreholes were advanced using rotary boring. Standard penetration tests (SPT) were conducted in the borehole at an interval of 1 m. The borehole was terminated if rock was encountered or the SPT ‘N’ value was greater than or equal to 100.

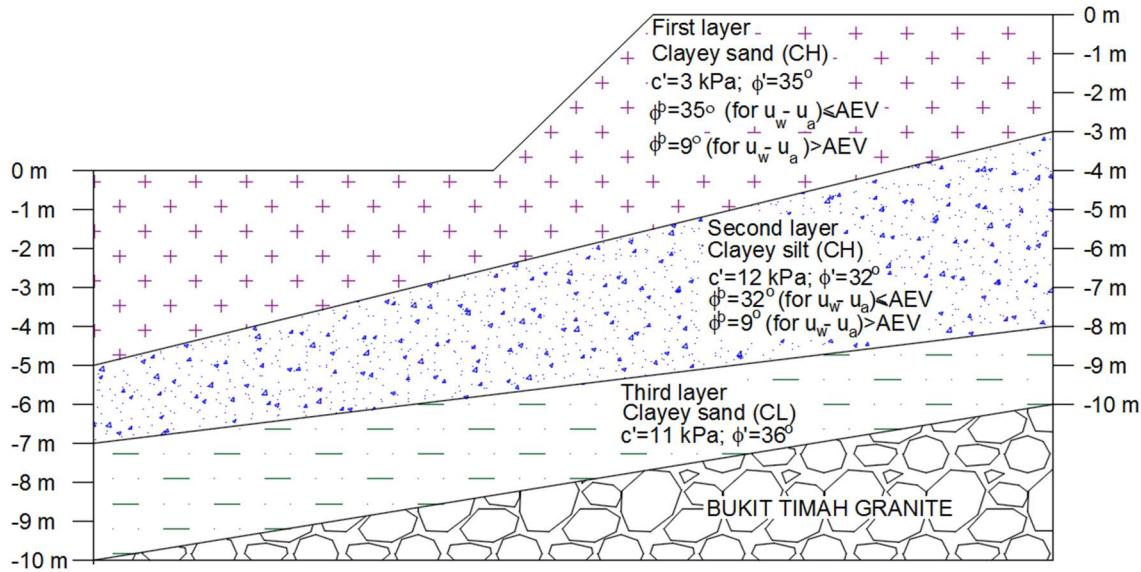
**Figure 8: Simplified soil profile of residual soil slope at Pilot study site**

site is presented in [Figure 8](#). Groundwater table was estimated at depth of 3m below the ground surface at crest and 2 m below ground surface at toe.

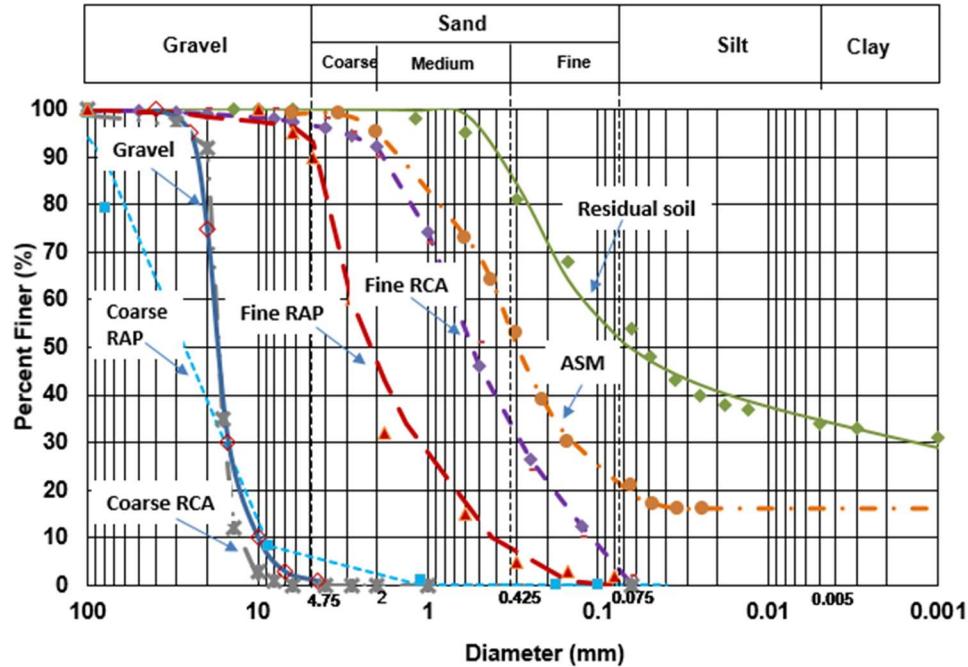
**Figure 9: Grain size distribution of residual soil and GBS construction material**

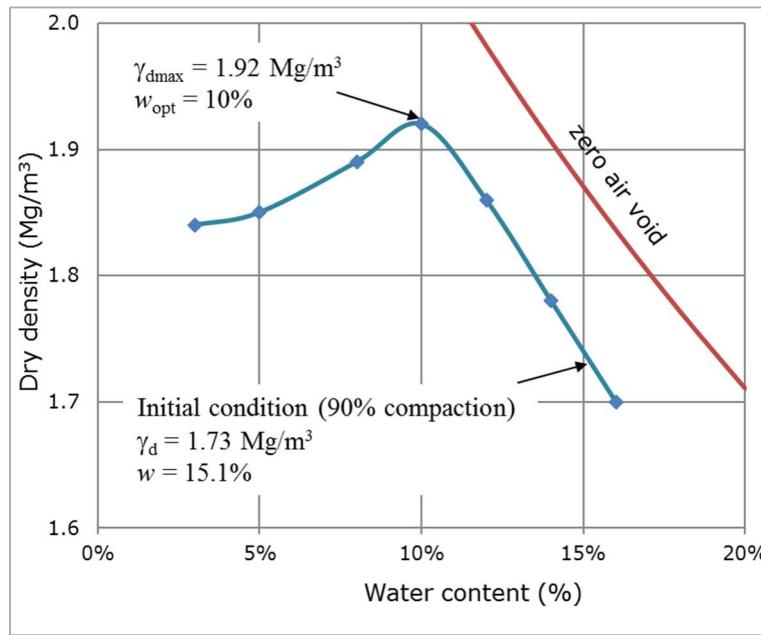
**Figure 10: Laboratory compaction curve for reinforced soil fill**

The reinforced soil was derived from in-situ residual soil. The soil was compacted to 90% of compaction level based on the maximum density obtained from laboratory compaction curve. The compaction test was carried out following ASTM D698-12. Figure 10 shows the compaction curve of residual soil from Layer 1. Based on the compaction curve, the maximum dry density and optimum water content for the compaction of the residual soil are  $1.92 \text{ Mg/m}^3$  and 10%, respectively. For the pilot study, the soil was compacted at dry density of higher than  $1.73 \text{ Mg/m}^3$  and water content of 15.1%.

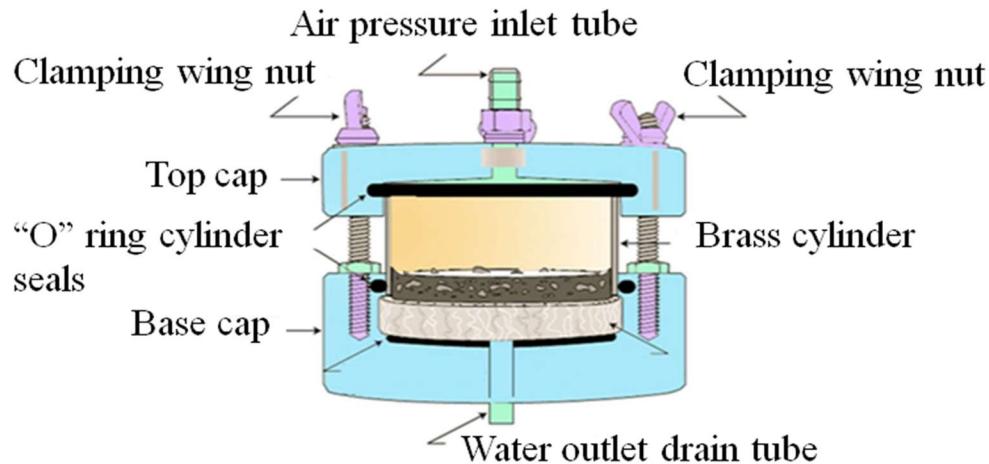
**Figure 11:** Schematic diagram of Tempe cell (Rahardjo et al, 2007b)

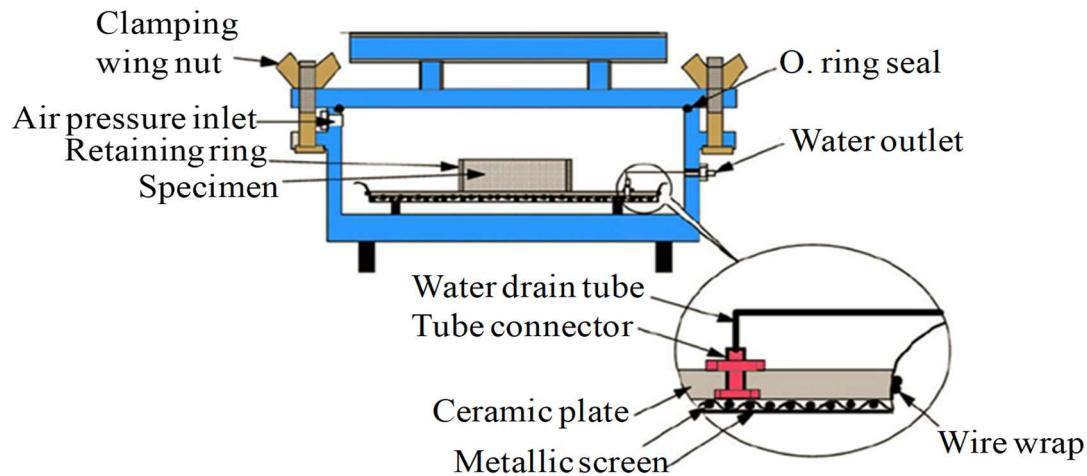
**Figure 12:** Schematic diagram of pressure plate (Rahardjo et al, 2007b)

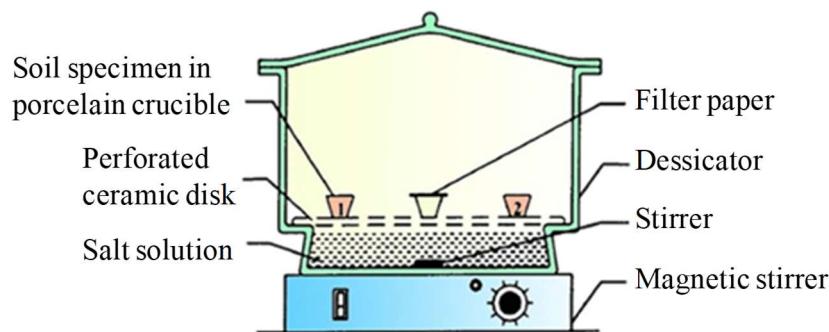
**Figure 13:** Schematic diagram of salt solution test apparatus (Agus et al, 2001)

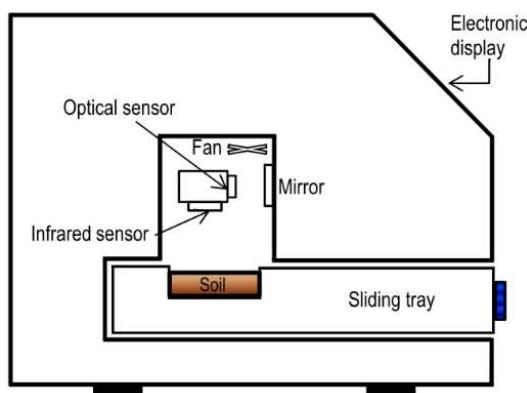
**Figure 14:** Schematic diagram of dew point method apparatus

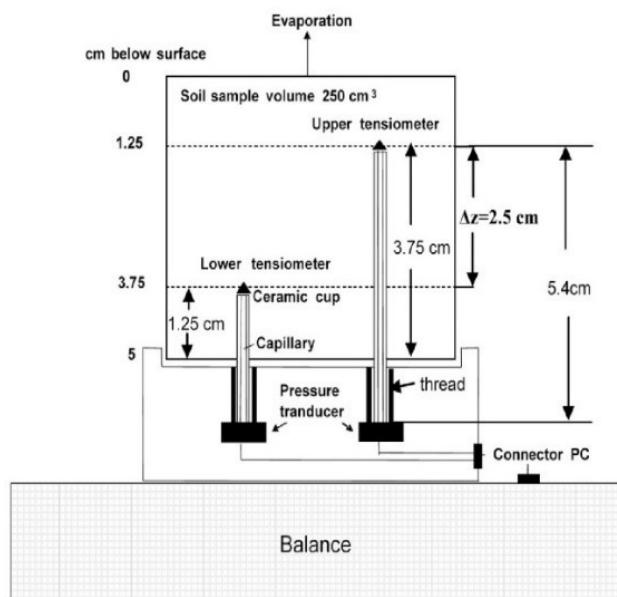
**Figure 15:** Schematic diagram of hyprop apparatus (Schindler et al, 2010)

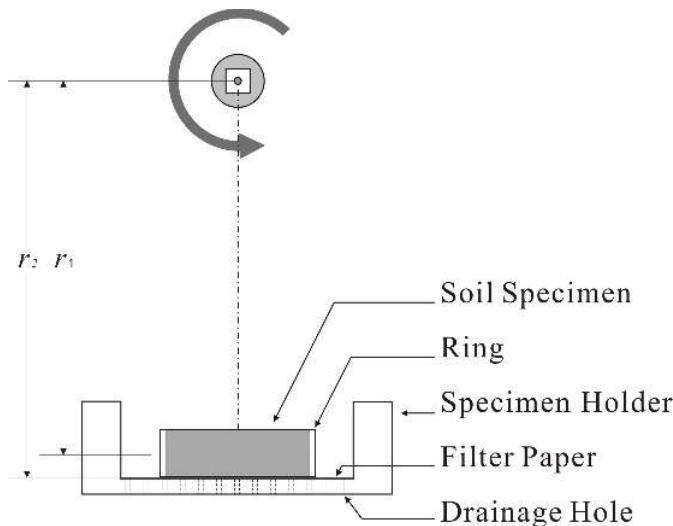
**Figure 16: Schematic diagram of mini centrifuge apparatus (Rahardjo et al, 2018a)**

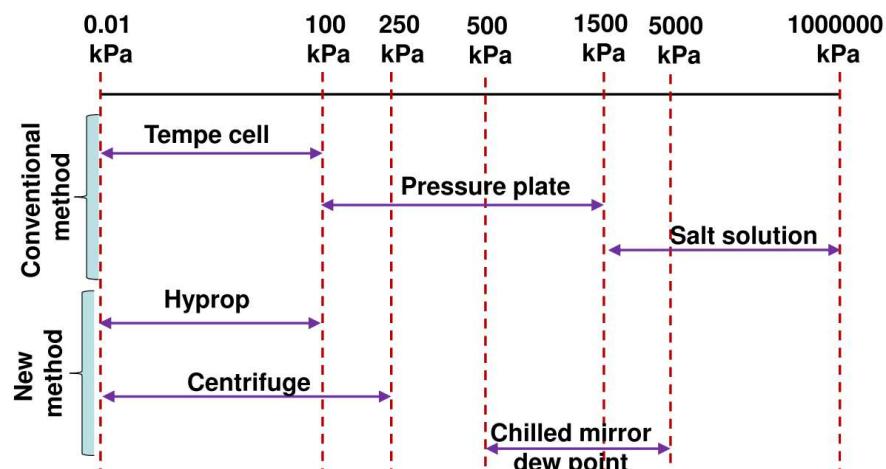
**Figure 17: Range of suction applicable for SWCC measurement techniques**

**Figure 17.** The details and procedures of SWCC tests using Hyprop is explained in Schiendler et al (2010) while the other methods are standardized in [ASTM D6838-02](#).

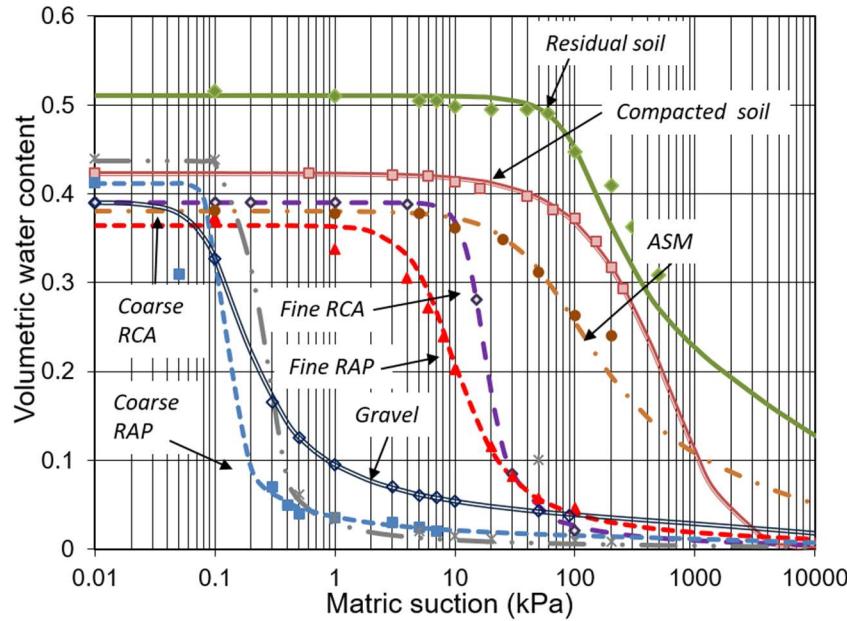
**Figure 18: Drying SWCC of in-situ soil and construction materials of GBS slopes**

Most apparatuses can be used to perform SWCC test for drying process. However, it is important to plot the SWCC for drying and wetting process because most of the geotechnical problems, such as slope failure, are induced by rainfall that generally causes a wetting process in soil. Thus, the SWCC tests were carried out in this study under both drying and wetting processes using various apparatuses available at NTU Geotechnics Laboratory. The SWC drying curves of residual soil from the pilot study site as well as construction materials for GBS slopes are presented in [Figure 18](#) while the wetting curves

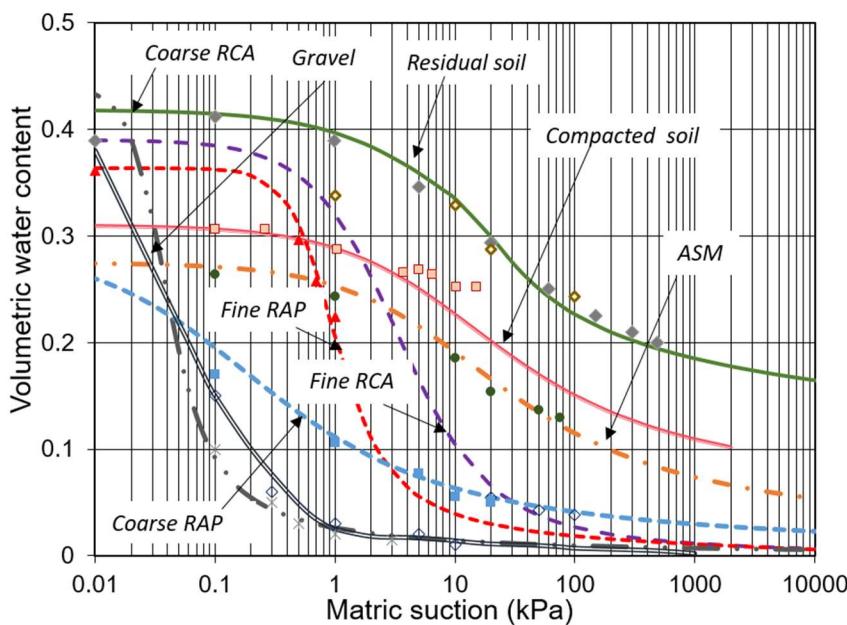
**Figure 19: Wetting SWCC of in-situ soil and construction materials of GBS slopes**

are presented in [Figure 19](#). The fitting parameters and SWCC parameters of residual soil and all materials involved in the construction of the GBS at Orchard Boulevard are summarized in Table 4.

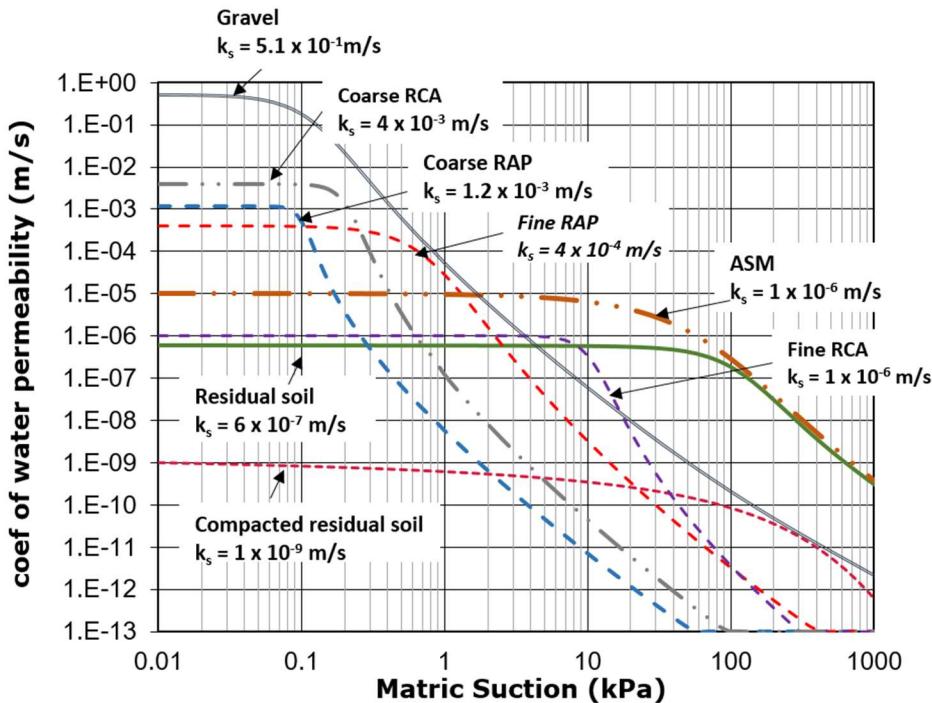
Figure 20: Permeability functions of residual soil and GBS construction materials

The determination of unsaturated coefficient of permeability by experiment is a tedious and time-consuming process. Therefore, an indirect method using a statistical model is commonly used to predict the permeability function from the saturated coefficient of permeability,  $k_s$ , and the soil-water characteristic curve (Fredlund and Xing, 1994; Marshall, 1958; Millington and Quirk, 1959, 1961; Kunze, 1968; Green and Corey, 1971). The calculated permeability data can then be fitted using the mathematical equation as suggested by Leong and Rahardjo (1997). In this study, the drying and wetting permeability functions were both considered. However, previous study (Tami et al, 2004) showed that wetting permeability function is more suitable for the study of rainfall infiltration under both drying and wetting conditions. Figures 20 shows the wetting permeability functions of the residual soil and all construction materials used for the construction of GBS at the pilot study site.

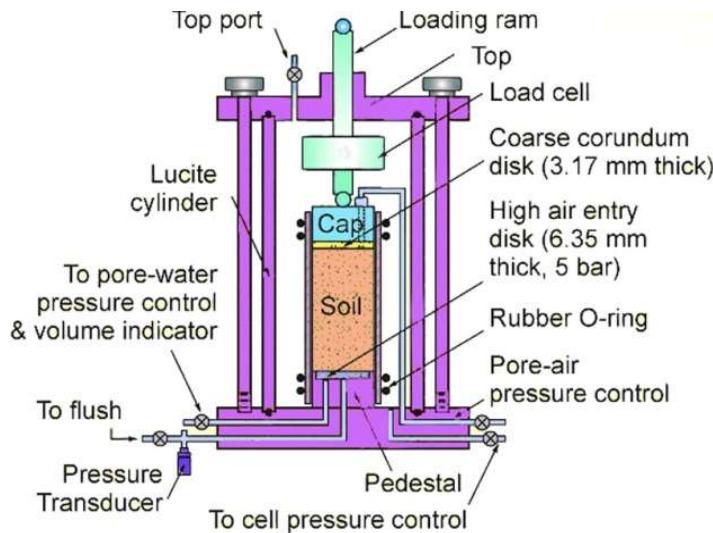
**Figure 21: Schematic diagram of modified triaxial cell for unsaturated soil test**

Unsaturated shear strength parameter ( $\phi^b$ ) of the residual soil and construction materials for GBS were obtained using the modified triaxial apparatus (Fredlund and Rahardjo, 2003) under consolidated drained (CD) condition following ASTM D7181-11. The schematic diagram and the configuration of the triaxial apparatus is shown in Figure 21. The apparatus is capable of controlling as well as measuring pore-air and pore-water

pressures in the soil specimen independently by using the axis-translation technique in order to achieve the desired matric suction. The details and procedures of unsaturated triaxial tests can be found in Fredlund et al. (2012) and Fredlund and Rahardjo (1993). The results of the unsaturated triaxial CD tests were interpreted using Mohr circles. The failure envelope sloping at an angle of  $\phi'$  was drawn tangent to the Mohr circles at failure. The failure envelope intersected the shear strength versus matric suction plane at a cohesion intercept,  $c$ . The cohesion intercepts obtained at various matric suctions were joined to determine the  $\phi^b$  angle. The unsaturated shear strength parameters of residual soil and the materials used in the construction of GBS are summarized in [Table 5](#).

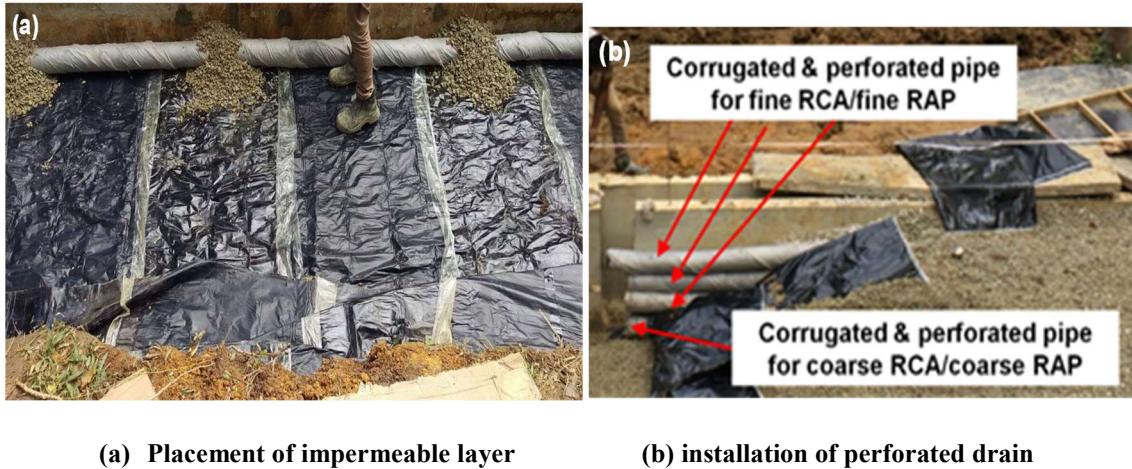
**Figure 22: Preparation work and drain installation**

The gravel layer was placed at 1 m depth from the ground surface below the toe of the slope. The gravel was compacted to a relative density between 70% - 90% or to the required dry density of minimum 1.8 Mg/m<sup>3</sup> using a portable compactor. Impermeable separator was installed to separate the gravel below coarse RCA/coarse RAP and fine RCA/fine RAP ([Figure 22a](#)). One corrugated and perforated pipe was placed at the end of the gravel layer to drain out the water from coarse RCA/coarse RAP. Three corrugated and perforated pipes were located at the end gravel layer to drain out the water from fine RCA/fine RAP and ASM ([Figure 22b](#)). The pipes were connected such that there was only one outlet to the surface drain. All pipes were wrapped with geotextile (Nonwoven Geotextiles TS20) to avoid migration of soil particles that can block the pipe holes. The ASM was placed into the geobag prior to the placement at the designated locations. The fine RCA and fine RAP were also placed into the geobag and compacted into a relative density between 70% - 90% or to the required dry density of minimum 1.55 Mg/m<sup>3</sup>. [Figure 23](#) shows the compaction works of fine RCA within the geobag.

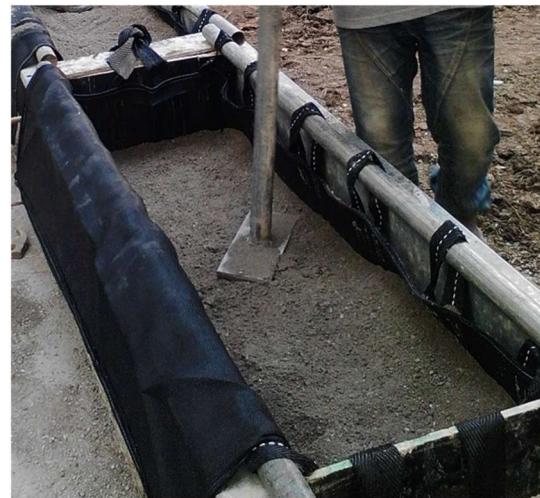
**Figure 23: Filling and compaction of fine RCA/fine RAP inside geobag**

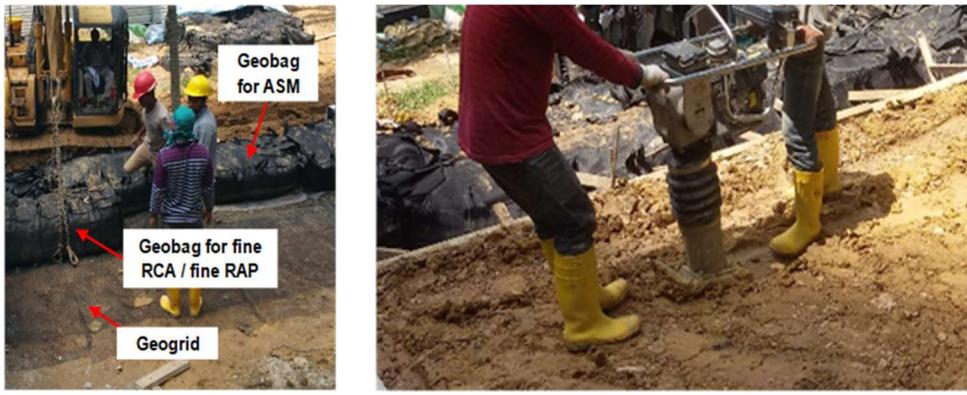
(a) Placement of ASM geobag and fine RCA/fine RAP geobags

(b) Compaction of residual soil behind Capillary barrier

The placement of geobag was carried out in stages. Every stage (500 mm height) was started with the placement of the ASM geobag. The geogrid attached to ASM geobag was stretched up to the maximum length of 2800 mm. Then the geobag for fine RCA/fine RAP was placed behind the ASM geobag ([Figure 24a](#)). Prior to the placement of coarse RCA/coarse RAP, the soil up to 1400 mm length behind the fine RCA/fine RAP geotextile bag was compacted to  $1.73 \text{ Mg/m}^3$  ([Figure 24b](#)). Then, the coarse RCA/coarse RAP was placed in between the fine RCA/fine RAP geobag and the compacted soil ([Figure 24c](#)). The coarse RCA/coarse RAP was compacted to the required dry density of  $1.8 \text{ Mg/m}^3$ .

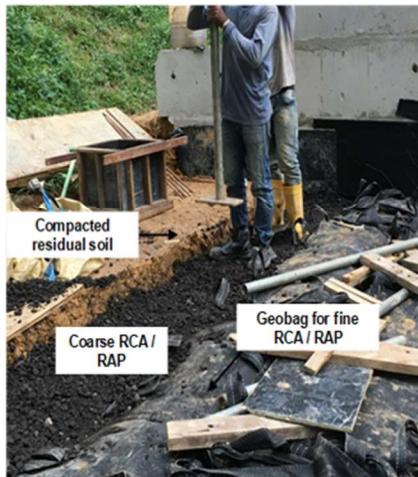
(c) Placement of coarse RCA/coarse RAP

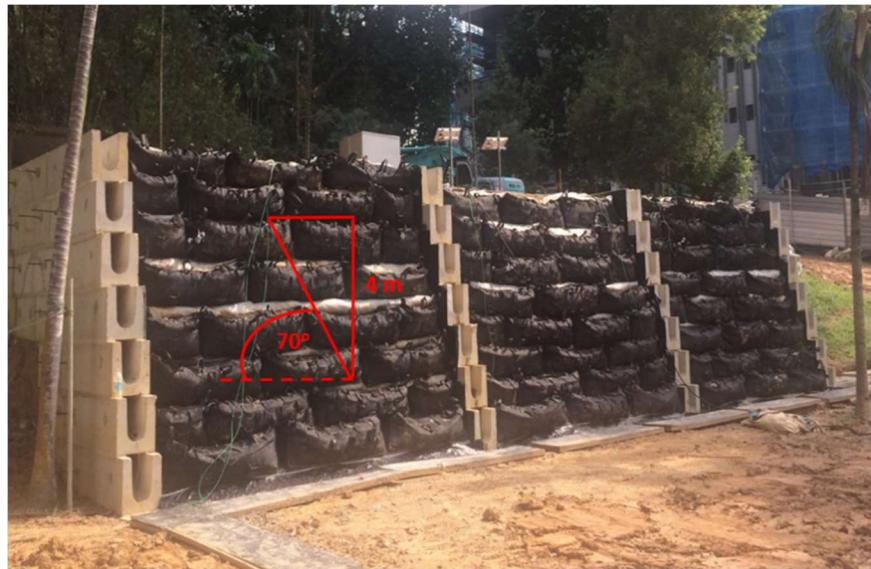
Figure 25: Completed GBS slopes at field pilot study site Orchard Boulevard

In the final stage of the GBS construction (at the crest of the slope), the coarse RCA/coarse RAP was placed directly above the ground surface behind the ASM geobag. Then, geofabric was placed on top of the coarse RCA/coarse RAP before placement of fine RCA/fine RAP. Another geofabric layer was placed before laying ASM layer. Then surface drain was constructed at the back and both sides of the GBS slopes. Vegetations were planted in each pocket of the ASM geobag upon the completion of the GBS slopes. The crest of the GBS slopes were then covered by turfing on the ASM layer. [Figure 25](#) and [26](#) show the completed GBS and the GBS with green cover, respectively.

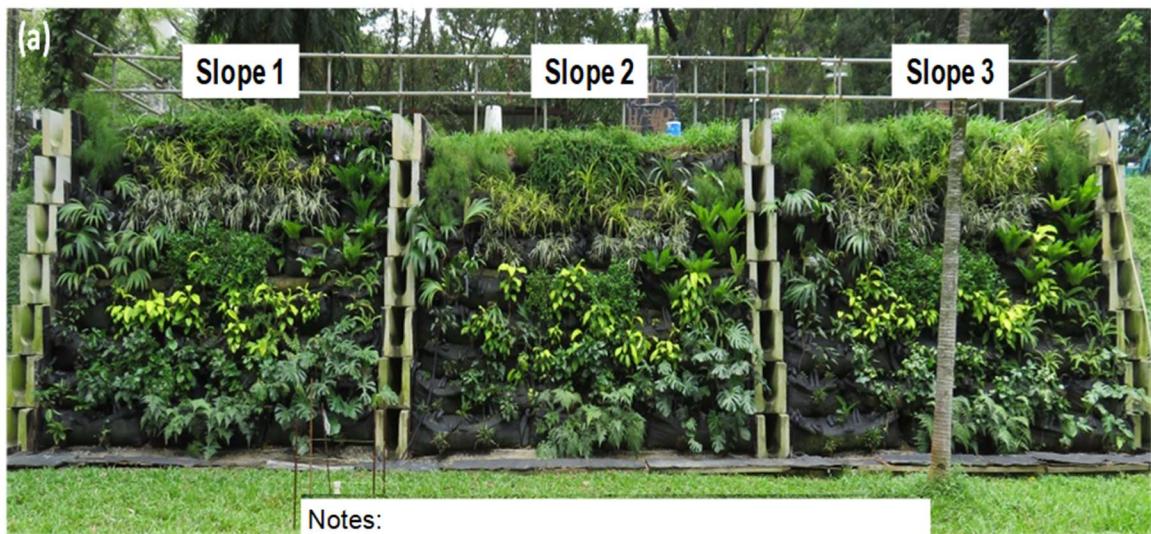
Figure 26: GBS slopes at field pilot study site Orchard Boulevard after planting

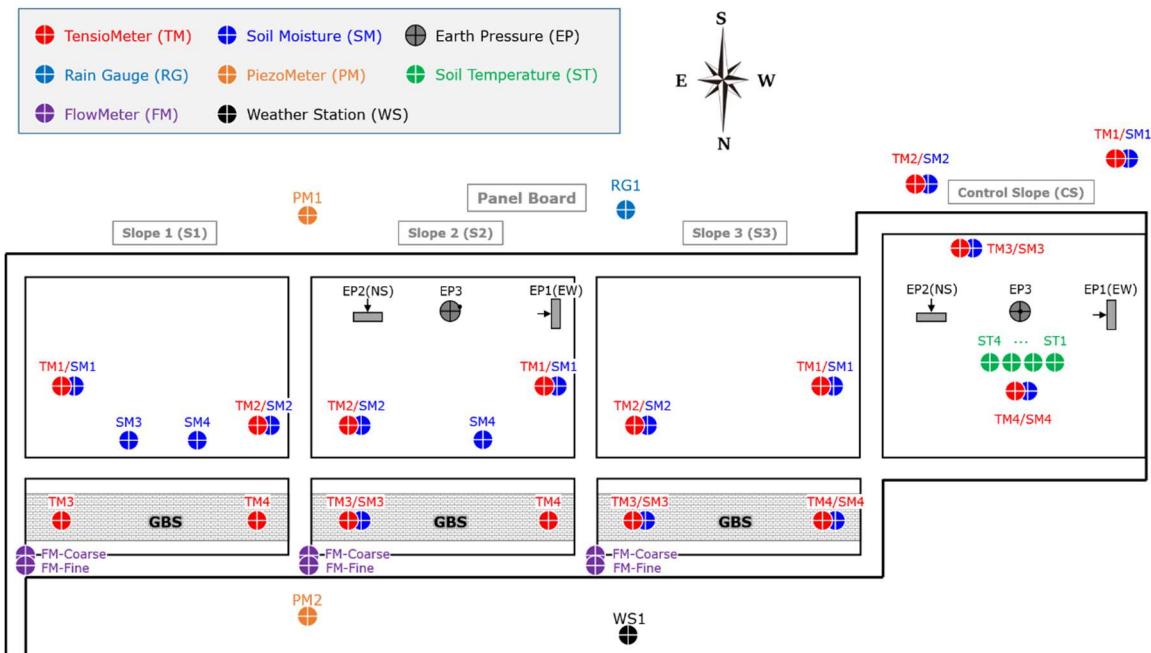
**Figure 27: Plan view of slopes at pilot study site with instrumentation locations**

Field instrumentation and monitoring was carried out on the GBS slopes and one section of the original slope to monitor the effect of rainfall on the pore water pressure and slopes deformation. The sensors used in the field instrumentation consisted of rain gauge, piezometers, tensiometers, soil moisture sensors, water flow meter, and earth pressure sensor to measure the slope deformation. All data were collected in a data-logger and transmitted via internet for remote access to enable real time observation. The monitoring period was one year commencing on 1<sup>st</sup> July 2016. The plan view of the slopes and instrumentation locations is presented in [Figure 27](#). The diagram of the GBS slopes and the Original slope constructed for this field study together with the layout of monitoring instruments are shown in [Figure 28](#).

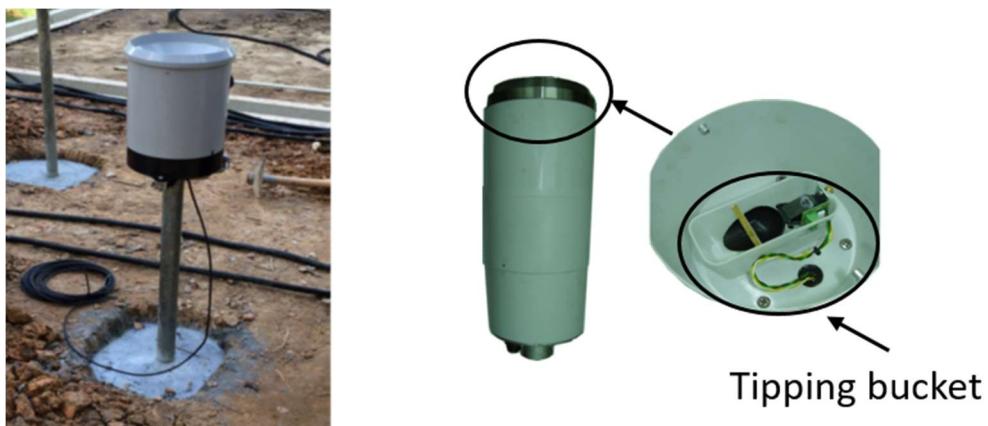
**Figure 29:** Tipping bucket rainfall gauge installed at the study site

The study area was instrumented with a rain-gauge ([Figure 29](#)) to monitor rainfall. The rain-gauge was located at 1.6 m above the ground on an open area of the slope crest to determine the rainfall intensity. A tipping bucket rainfall gauge, connected to a magnetic-reed switch, was chosen to collect the rainfall data. Regular maintenance of the rainfall gauge was conducted twice a week as dust and insects might enter the tipping bucket and affected the accuracy of measurement.

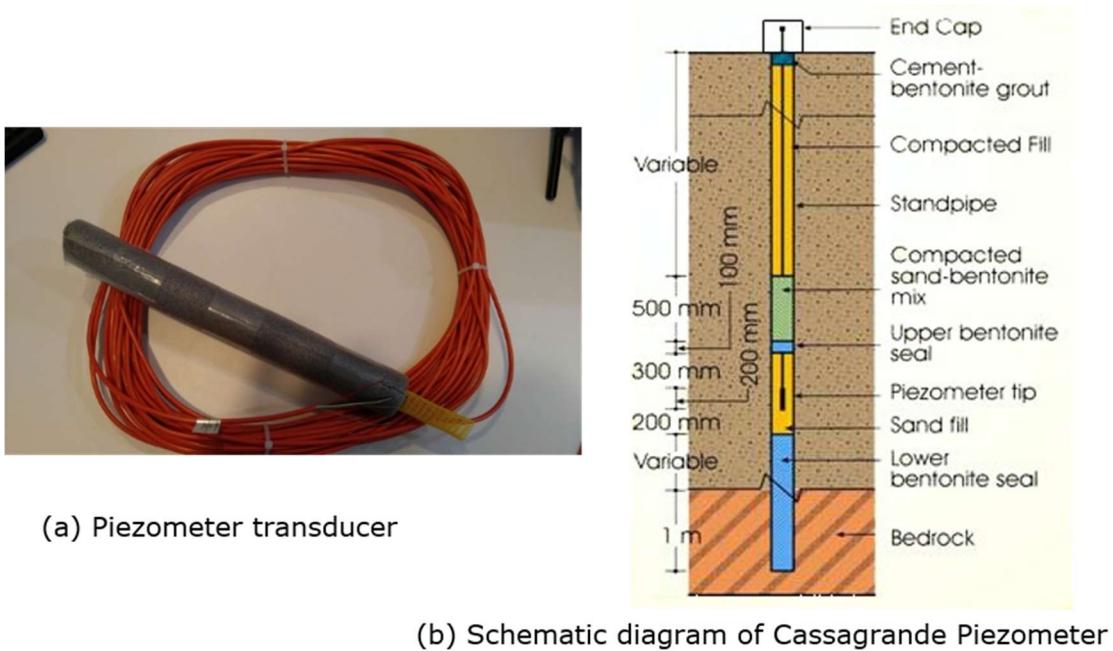
**Figure 30: Piezometer installed at the study site**

The response of groundwater to rainfall was monitored by two piezometers installed at depth of 7 m at the crest and depth of 4 m at toe of the slope. The piezometers, of Cassagrande type ([Figure 30](#)) is widely used for groundwater table monitoring in slope because they consist of economical components, simple to read, and have long-term reliability. The piezometer tip was embedded in sand layer that is isolated by two sand bentonite layers. A grout (i.e., mixture of sand and bentonite) was placed into the zone above the bentonite seals to prevent water migration through the zone into the intake area of the piezometer. The fluctuation of groundwater table in response to rainfall was monitored and recorded every week.

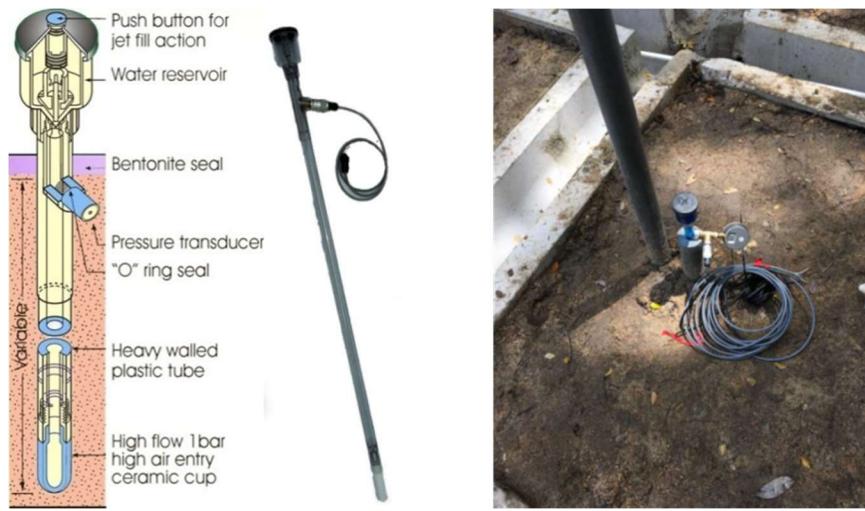
**Figure 31: Jet-fill tensiometer with transducer used in this study**

Four tensiometers were installed into the original slope and each GBS slopes to measure pore-water pressure change in response to rainfall infiltration. As shown in Figure 28, all tensiometers in original slopes were installed vertically from crest to a depth of 2 m. TM1 and TM2 of GBS slopes were also installed vertically from crest into compacted soil to a depth of 2 m while TM3 and TM4 were installed from the slope face to coarse and fine layers, respectively. The elevation of TM3 and TM4 from ground surface at crest were also 2 m. Prior to installation, the tensiometers were calibrated properly. Then, each jet-fill tensiometer was inserted inside the tube that has been provided during the construction of the GBS slopes until the tip of ceramic disc was embedded inside the soil. The jet-fill tensiometer (Figure 31) was supported with a bourdon gauge to verify the reading from transducer. The response of tensiometers to pore-water pressure change must be checked regularly to ensure the quality and physical performance of high air-entry ceramic tips. In this study, regular maintenance of the tensiometers was conducted twice a week by refilling the jet-fill reservoir with de-aired water and flushing the tensiometers to remove the accumulated or trapped air in the tensiometer tubes caused by cavitation of water and air diffusion through the ceramic tip.

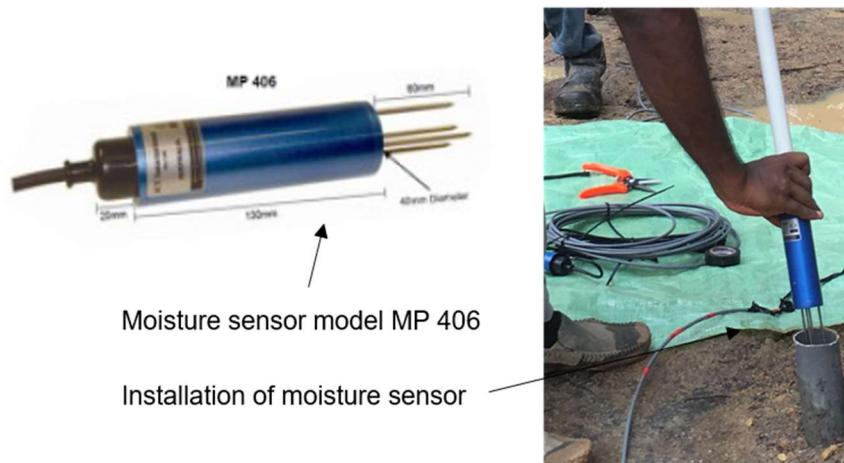
**Figure 32: Soil moisture sensor used in this study**

The soil moisture sensor model M406 used in this study was of TDR type which was capable of measuring soil moisture up to saturation (0–100%) with accuracy of 1% and response time of 0.5 second. All soil moisture sensors were tested in water and air environment and their values corresponded to the values specified by manufacturer which was about 70 to 90% in pure water and zero in air. [Figure 32](#) shows the soil moisture sensor and installation of the moisture sensors used at the pilot field study at Orchard Boulevard.

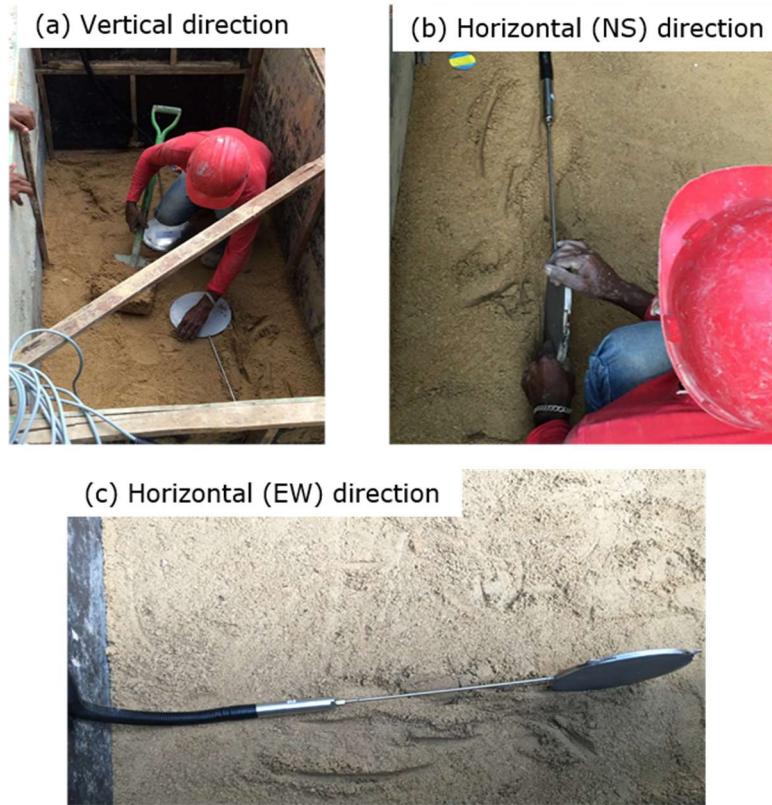
**Figure 33: Installation of Earth pressure cells in GBS slope 2**

Earth pressure cells were installed behind the original slope and GBS slope 2 to monitor the total vertical and lateral stresses changes due to rainwater infiltration in three directions  $z$  (i.e., vertical direction),  $x$  (i.e., east-west direction: perpendicular to the inclination of the slope) and  $y$  (i.e., north-south direction: parallel to the inclination of the slope). The installation of the earth pressure cells was carried out carefully to minimise soil disturbance due to the excavation of the slot for a pressure cell. [Figure 33](#) shows the earth pressure cells installed in GBS slope 2.

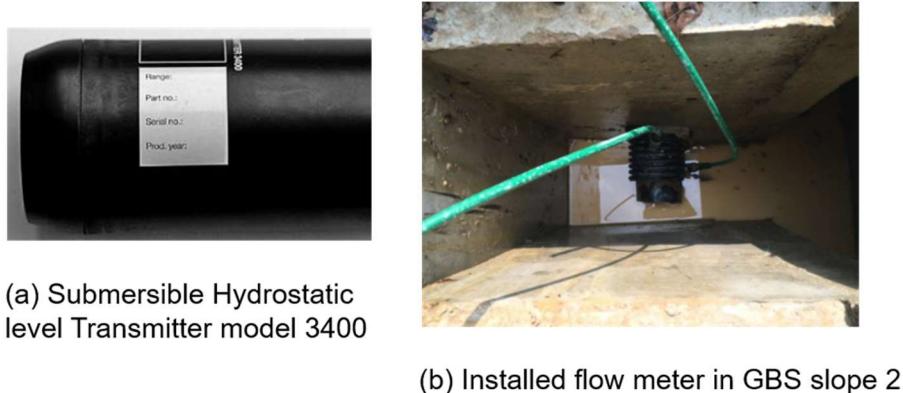
**Figure 34: Flow-meter installed below GBS slopes**

Each slope was served by two flowmeters, one monitored water flowing out from the fine-grained layer and the other monitored if there was water coming out from the coarse-grained layer. The flowmeter used in this pilot study is shown in [Figure 34](#).

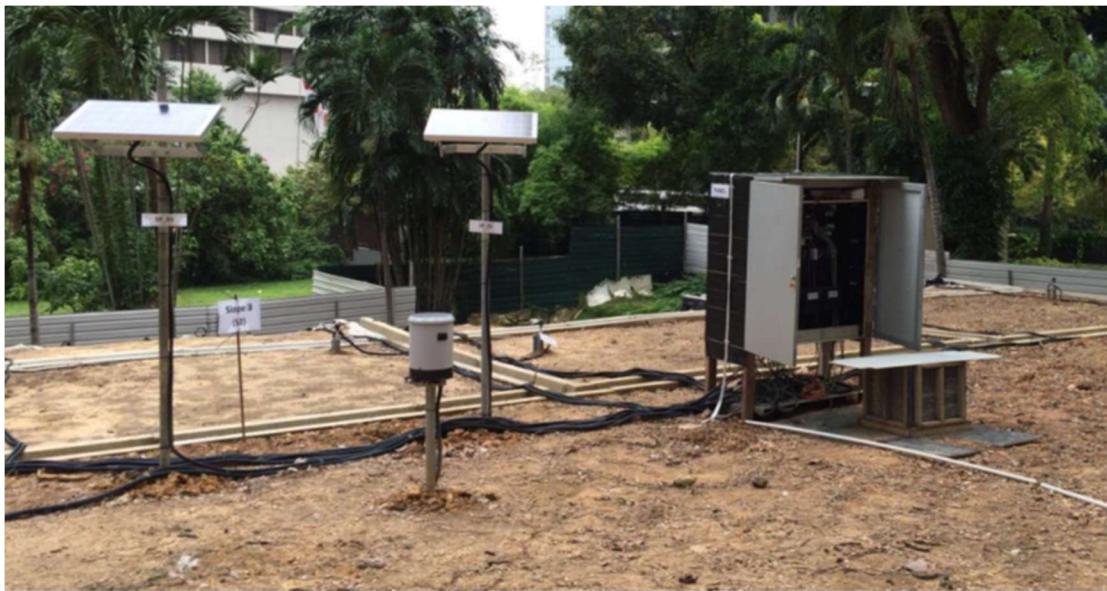
**Figure 35: Data acquisition system used at the study site**

The measuring instruments were calibrated in laboratory and checked on-site prior to installation, to obtain reliable readings. Readings of each instrument (tensiometers, soil moisture sensors, earth pressure cells, piezometers, rain-gauge) were checked before they were connected to a data acquisition system (DAS) to obtain instrumentation readings in real time. The data logger was powered by solar panel and battery. The cables were protected by corrugated tubing to prevent damages from rainfall and insects. The data logger recorded readings at a 10-minute interval regardless of rainfall events. [Figure 35](#) shows the data acquisition system used at the pilot study site at Orchard Boulevard.

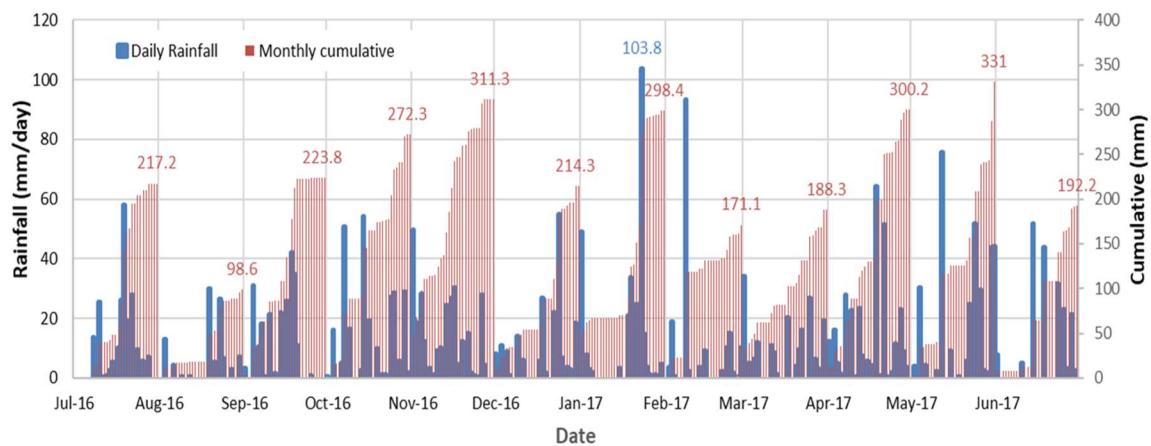
**Figure 36: Daily and monthly cumulative rainfall from 1st July 2016 to June 2017**

monthly rainfall in May 2017 (331 mm) was very high as compared to the average rainfall in Singapore for May (>200 mm). The monthly rainfall in September, October and November 2016 are higher than the average monthly rainfall for the months in Singapore. This inter-monsoon period in Singapore is usually wetter than March – May. Maximum daily rainfall occurred during the monsoon period in January 2017 i.e. 103.8 mm. The month of January 2017 started with a dry period for about two weeks but very wet period towards the end of the month. November 2016 was the wettest month during the monitoring period with cumulative rainfall of 311.3 mm rain and 21 rainfall days while August 2016 was the driest month with cumulative monthly rainfall of 98.6 mm. The highest cumulative rainfall occurred in May 2017 i.e. 331 mm with only 14 days of rainfall.
