## GEOBARRIER SYSTEM FOR USE IN UNDERGROUND STRUCTURE

# **GEOBARRIER SYSTEM FOR USE IN UNDERGROUND STRUCTURE**

*Research Collaboration between:*

**Nanyang Technological University  
Housing & Development Board**

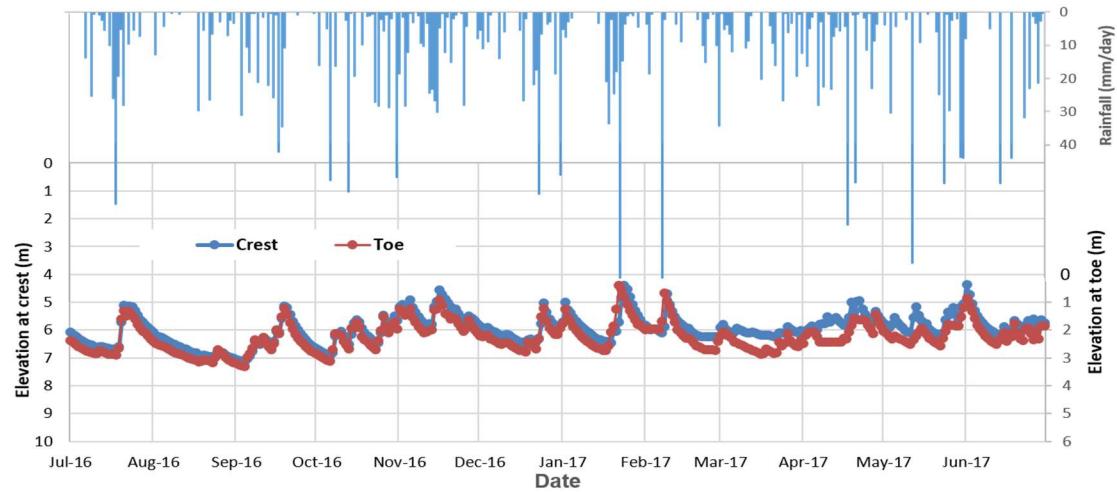
**Figure 37: Groundwater table fluctuation in response to rainfall infiltration**

below ground surface at the toe) a few times during the monitoring period, thus affected the reading of flow meter. The difference on the elevation at crest and elevation at toe is considered in Figure 37. It is shown that the groundwater table below the slopes at the pilot study site was almost flat with an average fluctuation of 2.8m. [Figure 38](#) shows the highest and lowest ground water table during the monitoring period.

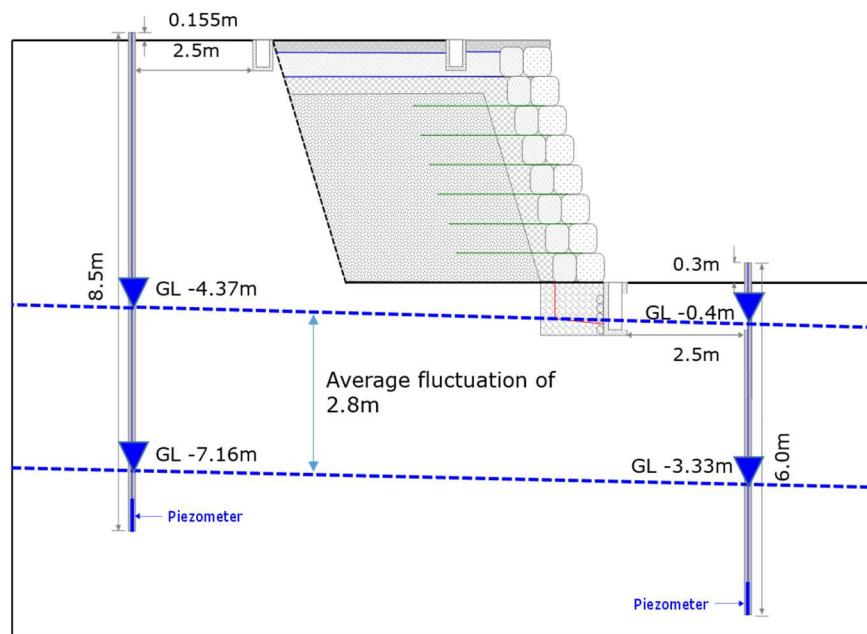
**Figure 38: Highest and lowest ground water table during the monitoring period**

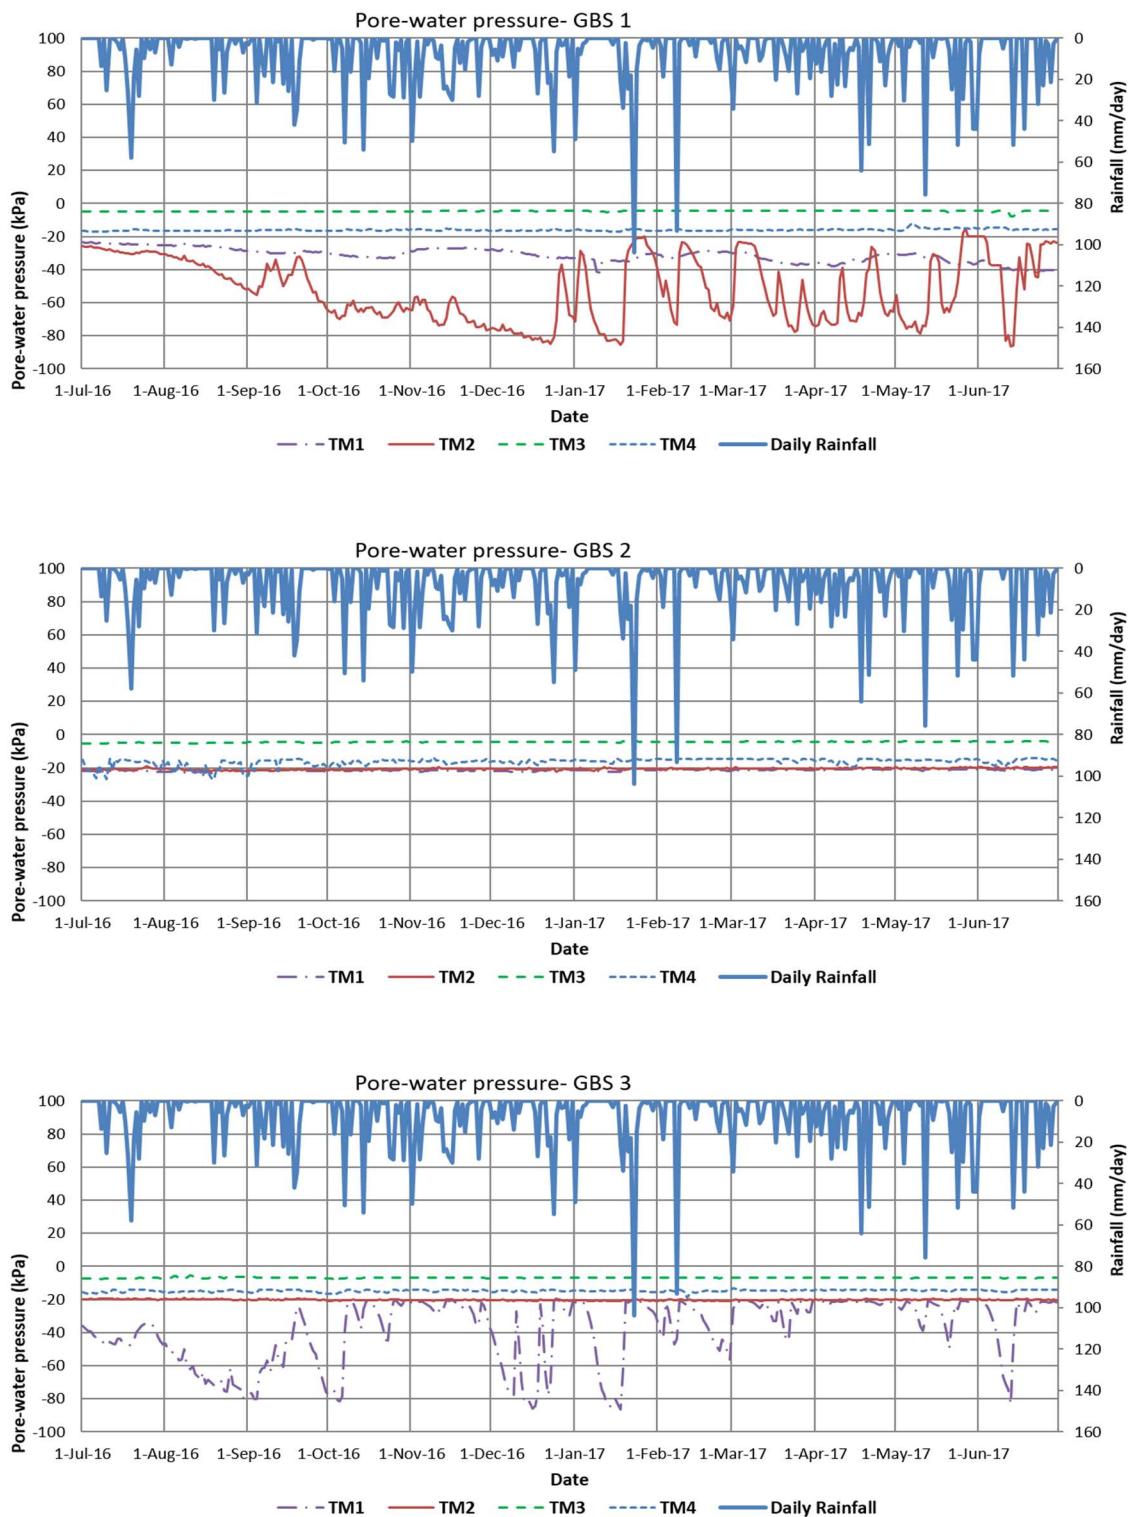
**Figure 39:** Pore-water pressure readings in the GBS slopes at pilot study site

As mentioned earlier, three GBS slopes and one section of the original slope were instrumented with tensiometers to observe the response of the slopes to rainfall infiltration in terms of pore-water pressure. [Figure 39](#) shows the pore-water pressure response of GBS slopes to rainfall. The figure indicated that there was not much variation of pore-water pressure recorded in the GBS slope 2. The pore-water pressure recorded by TM1-GBS2 (2.1m from slope face) only varied between 15 and 25 kPa while TM2-GBS2 (1.1 m from slope face) recorded almost constant values. The pore-water pressure in Coarse RAP (TM3) was always constant with time while the readings from TM4 (fine grained layer) fluctuated slightly. On the other hand, the variation of pore-water pressure readings in TM2 of GBS slope 1 and TM1 of GBS slope 3 were quite significant. During long dry period, the pore water pressure could reach -80kPa but the reading recovered as soon as rain started to fall. This could be due to the effect of uneven compaction in the soil. Even-though the pore-water pressure in the compacted soil of GBS slopes 1 and 3 decreased to -80 kPa during dry periods, the pore-water pressure never increased to higher than -15 kPa during rainfall. This means that the change in the pore-water pressure was only due to the change in the moisture content of the soil and rainfall did not actually seeped into the compacted soil. The pore-water pressure readings of TM1 of GBS slopes 1 and TM2 of GBS slope 3 were similar with readings of TM1 and TM2 of GBS slope 2.

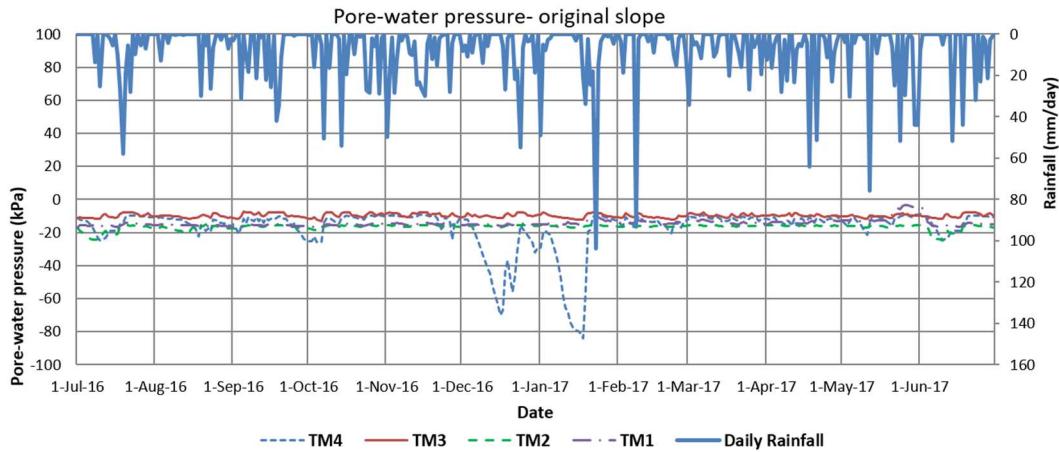
**Figure 40: Pore-water pressure readings in original slope at pilot study site**

[Figure 40](#) shows the response of tensiometers installed in Original slope to rainfall on average daily basis. All tensiometers in the original slope recorded change in pore-water pressure in response to rainfall infiltration. The tensiometers were installed at horizontal distances of 0.4 m (TM4), 2.4 m (TM3), 3.8 m (TM2), and 4.6 m (TM1) from slope face at depth of 2 m. The response of TM4-OS at distance of 0.4m is very significant due to long dry period and high air temperature in December 2016 and early January 2017. The response was more significant as the distance of tensiometer is closer to ground surface. With the exception of this period, the pore-water pressure in all tensiometers varied from -5 to -25 kPa throughout the monitoring period.

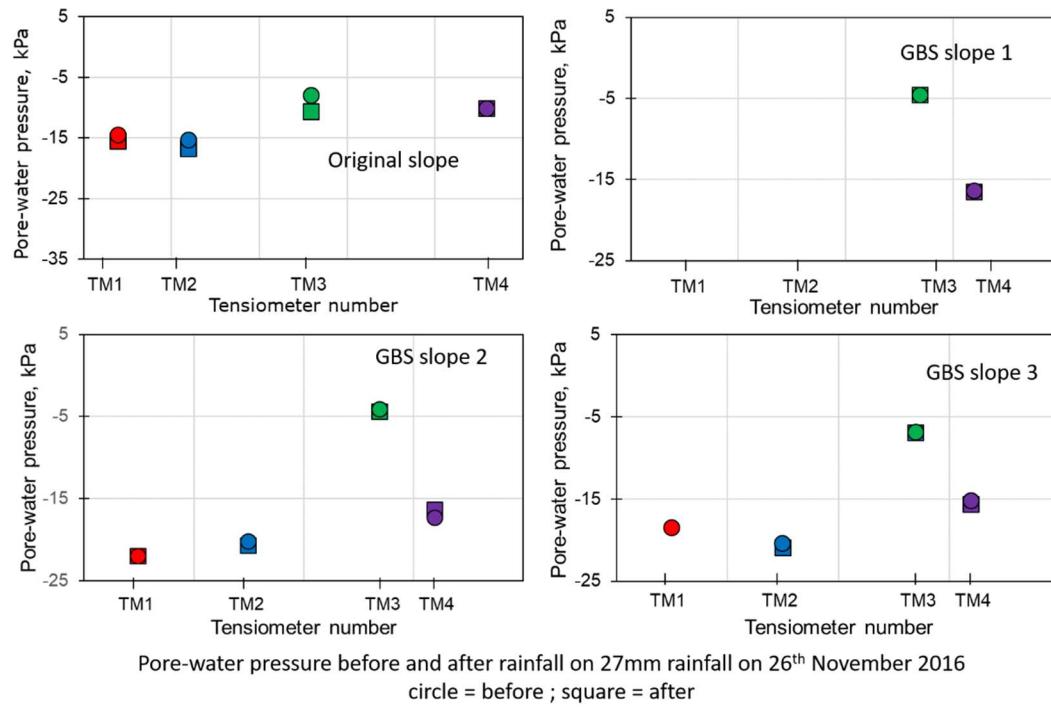
**Figure 41: Pore-water pressure response of original and GBS slopes**

The pore-water pressure readings from the GBS slopes were compared to the readings from the original slope, to identify the performance of the capillary barrier in limiting rainfall infiltration to soil. Comparison of the pore-water pressure variations presented in Figures 39 and 40 supports that the capillary barrier performed well in maintaining the negative pore-water pressure (suction) in the compacted soil. The pore water pressure recorded in the original slopes was higher than those recorded in the compacted soil within the GBS slopes. The pore-water pressure measured by TM3 in coarse grained layer was always constant, meaning that the rainfall did not infiltrate into this layer. The pore-water pressure in the fine grained layer fluctuated with rainfall but never reached zero indicating that the layer was affected by rainfall but the water never saturated the fine grained layer. The pore-water pressure measured in original slope varied in response to rainfall. However the variation recorded by TM4, was the most significant. This could be due to the position of TM4 which was closest to the ground surface (perpendicular distance to slope face was 0.23 m), thus readings of TM4 was subjected to the effect of evapotranspiration as well as the ASM soil used to grow the vegetation.

was 27 mm. This rainfall induced more variation in the pore-water pressure readings in the original slope as compared to the pore-water pressure readings in GBS slopes.

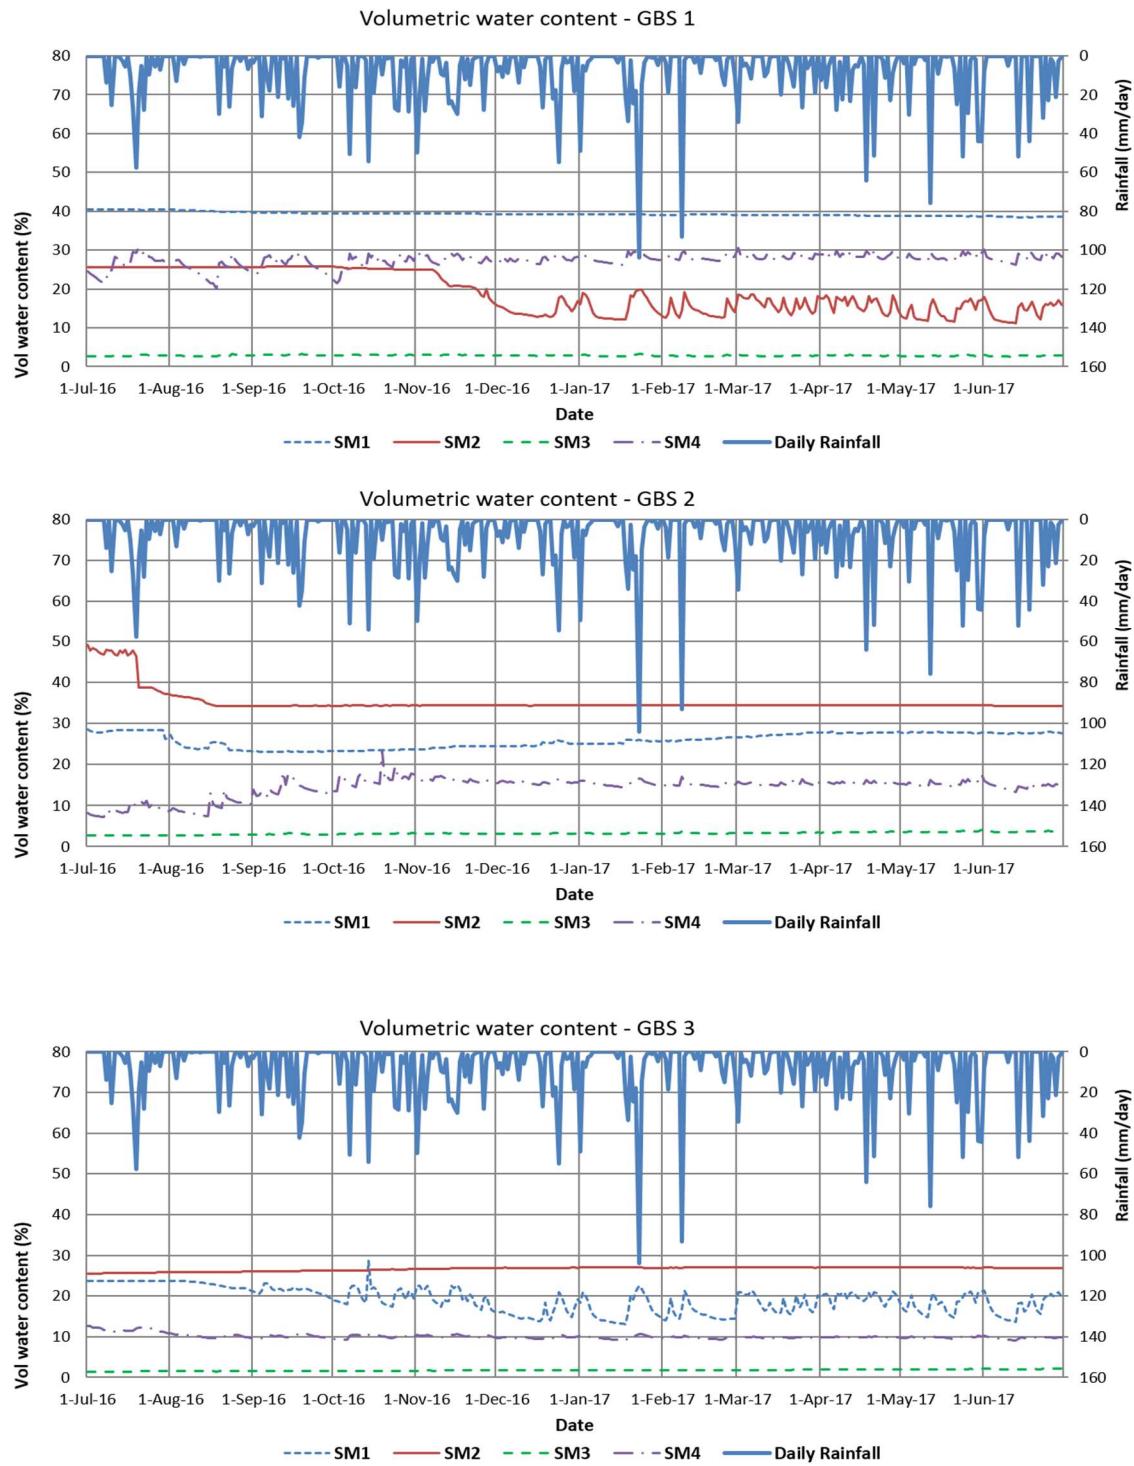
**Figure 42: Volumetric water content readings in the GBS slopes at pilot study site**

The soil moisture responses to rainfall infiltration in GBS slopes are shown in [Figure 42](#). In general, the soil moisture in the compacted soil within the GBS slopes (TM1 and TM2) varied from 10 to 35 kPa. The volumetric water content in fine RCA in GBS slope 1 was between 20 to 30% while in GBS slope 3 was about 10%. The volumetric water contents in fine RAP in GBS slope 2 varied between 8 and 20%. The volumetric water contents in the coarse aggregate (RCA and RAP) were lower than 7%. [Figure 43](#) shows the soil moisture response in the original slope. The volumetric water content in the residual soil forming the original slope varied from less than 10% to 55%. This variation was more significant than that in the GBS slope. This supports that the capillary barrier played its role to prevent rainwater to infiltrate into the coarse grained layer as well as the reinforced soil. The soil moisture readings at GBS slope were almost constant with time except in the fine-grained layer, meaning that the rainfall did not infiltrate into these layers.

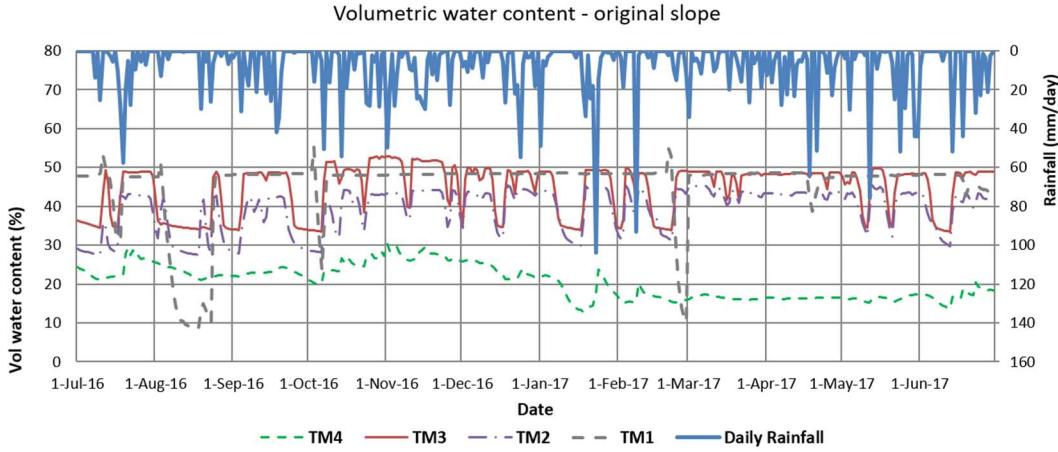
**Figure 43: Volumetric water content readings in original slope at pilot study site**

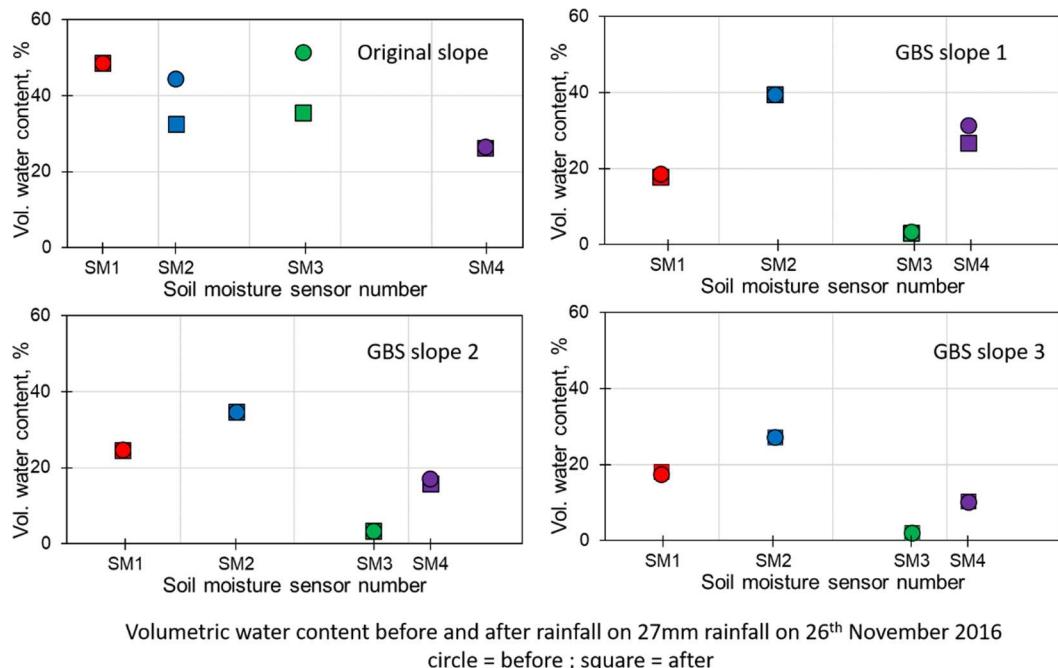
**Figure 44: PWP and VWC response of original slope and GBS slopes**

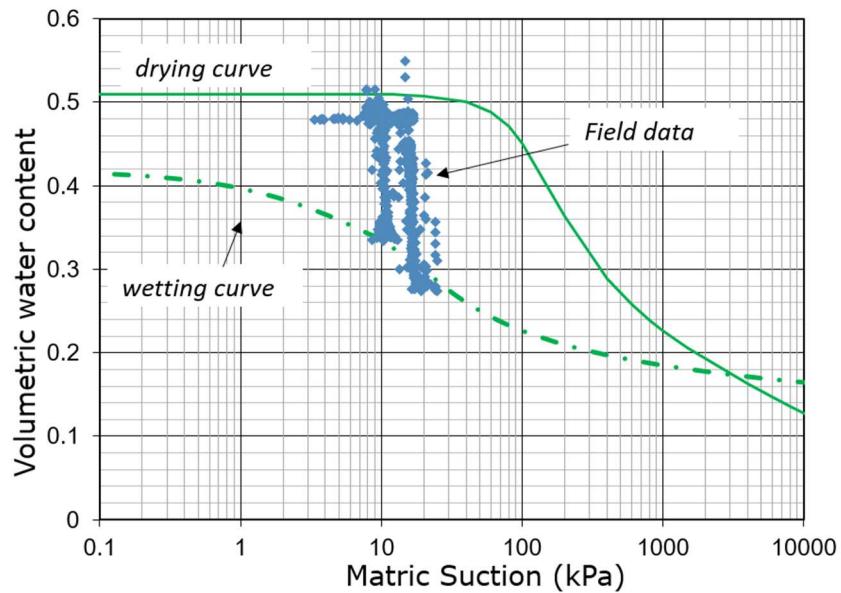
**Figure 45:** Plot of Field measurements in original slope on SWCC of residual soil

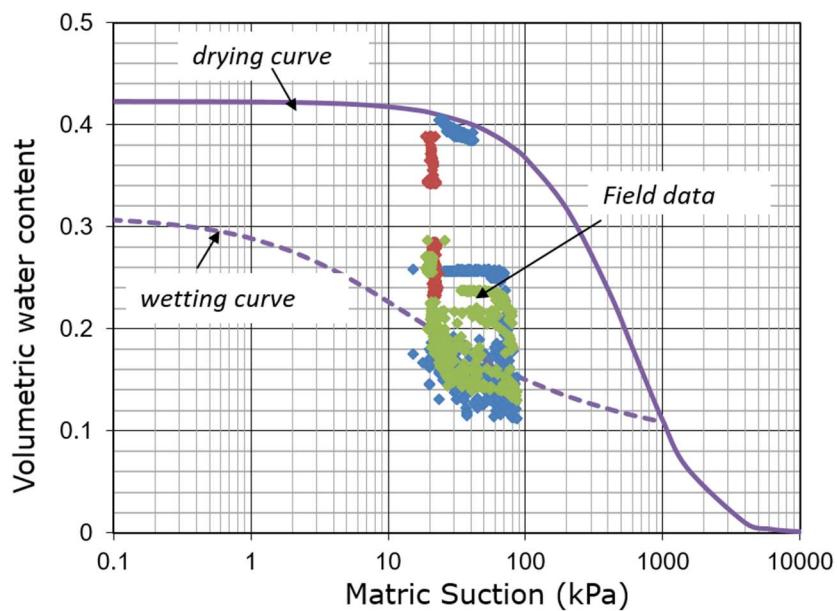
**Figure 46: Plot of Field measurements in GBS slopes on SWCC of compacted soil**

[Figure 46](#) shows the plot of field data on compacted soil in GBS slopes 1, 2 and 3. This figure also shows that all field data fall within the hysteretic loop of drying and wetting curves of the compacted residual soil. The plot of field data in coarse and fine materials forming the capillary barrier of GBS slopes are shown in [Figure 47](#) and [48](#). Most field data for coarse materials (RCA and RAP) are in the residual part of the SWCC. This is due to the condition of coarse RCA during construction was dry. Rainwater did not infiltrate into the coarse RCA, thus maintaining the dry or residual condition. The field data on fine materials (RCA and RAP) varied more significantly in terms of volumetric water content. For fine RCA, the data was concentrated in the transition zone of SWCC drying curve. Lower volumetric water contents were recorded in GBS slope 3. For fine RAP, the data concentrated toward the residual zone of SWCC due to the initial condition RAP.

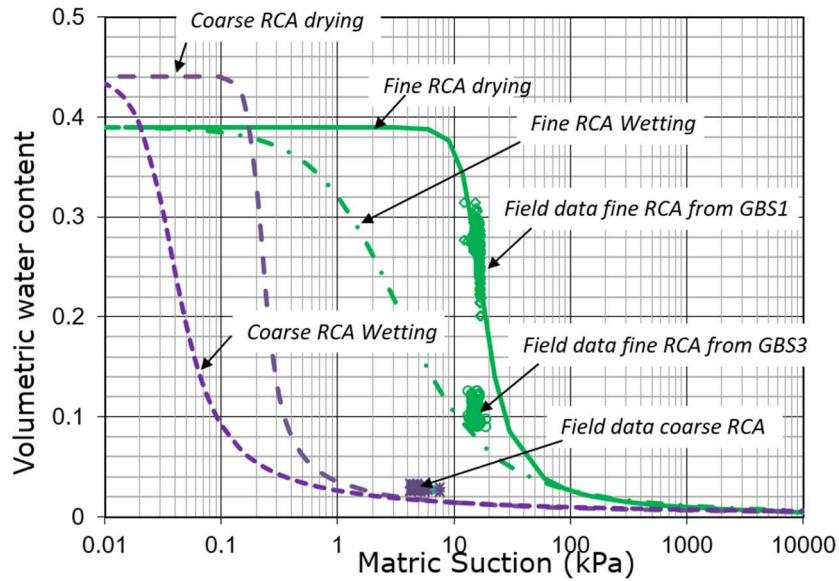
**Figure 47: Plot of field measurements in GBS slopes on SWCC of RCA**

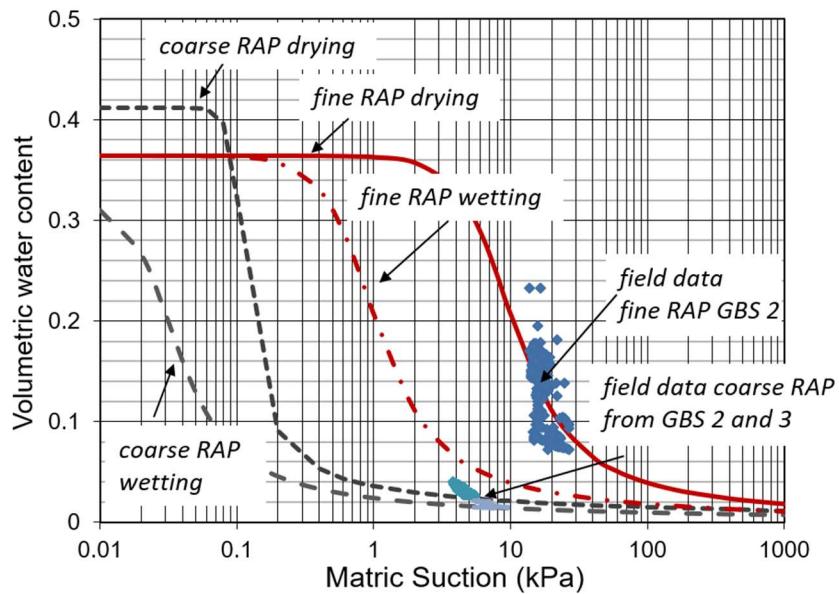
**Figure 48: Plot of field measurements in GBS slopes on SWCC of RAP**

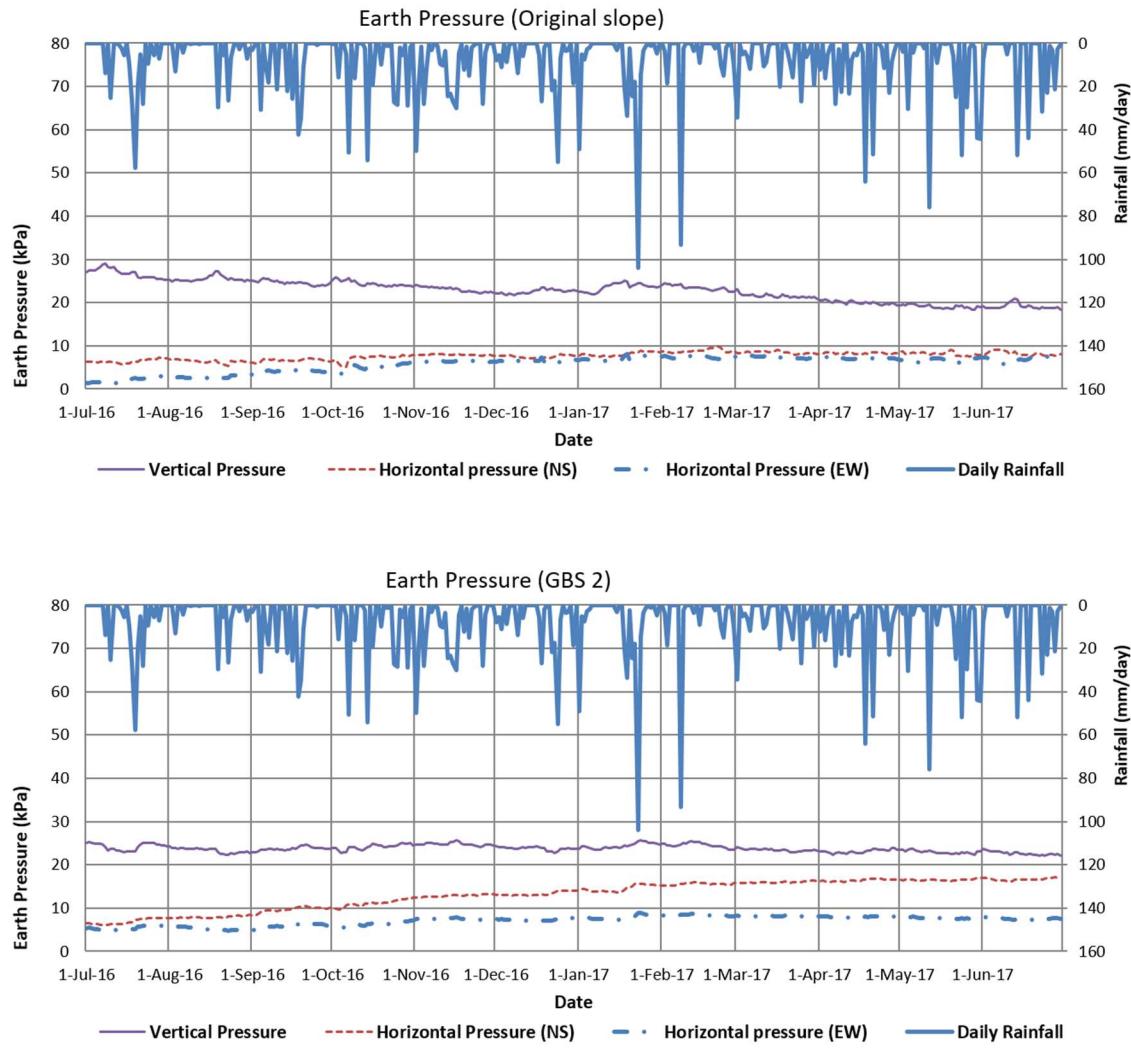
**Figure 49: Earth pressure variation in original slope and GBS slope 2**

While all slopes were instrumented with tensiometers and soil moisture sensors, only GBS slope 2 and original slope were also instrumented with earth pressure cells. The cells were installed at depth of 1.5 m from the ground surface at the crest. Earth pressure variations in the original slope and GBS slope 2 are shown in [Figure 49](#). The figure indicated that the vertical pressures (z- direction) recorded in both GBS slope 2 and the original slope are equivalent to the theoretical value assuming the density of the soil was  $1.8 \text{ Mg/m}^3$ . The vertical earth pressure recorded in GBS slope was less affected by rainfall than that recorded in the original slope. In the original slope, the horizontal pressure in y-direction started at a value lower than in the x-direction but with time, the values became closer. On the other hand, in GBS slope 2, the horizontal pressures were similar in x- and y- directions but the pressure in y-direction increased more significantly with time. The horizontal pressure in both y- and x-directions increased in the wet period and was remained constant during dry period.

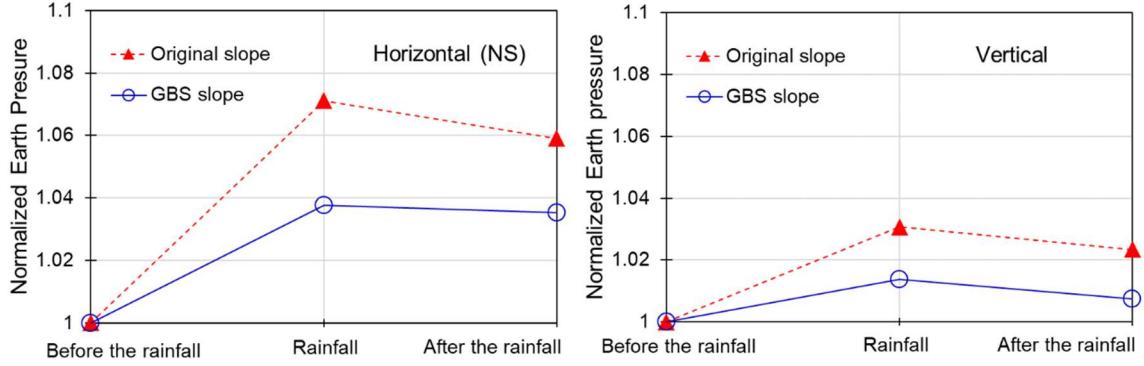
**Figure 50: Earth pressure responses to rainfall on 26<sup>th</sup> November 2016**

Weekly monitoring indicated that individual rainfall caused an immediate increase of vertical and horizontal pressure but the stress increase was released after a while. [Figure 50](#) shows the response of earth pressure readings to individual rainfall on 26<sup>th</sup> November 2016. The immediate pressure increase in both original and GBS slopes was believed to be due to the accumulation of water on crest and ASM layer of GBS before it was drained. [Figure 50](#) shows that the immediate pressure increase in GBS slope is less than the increase in the original slope.

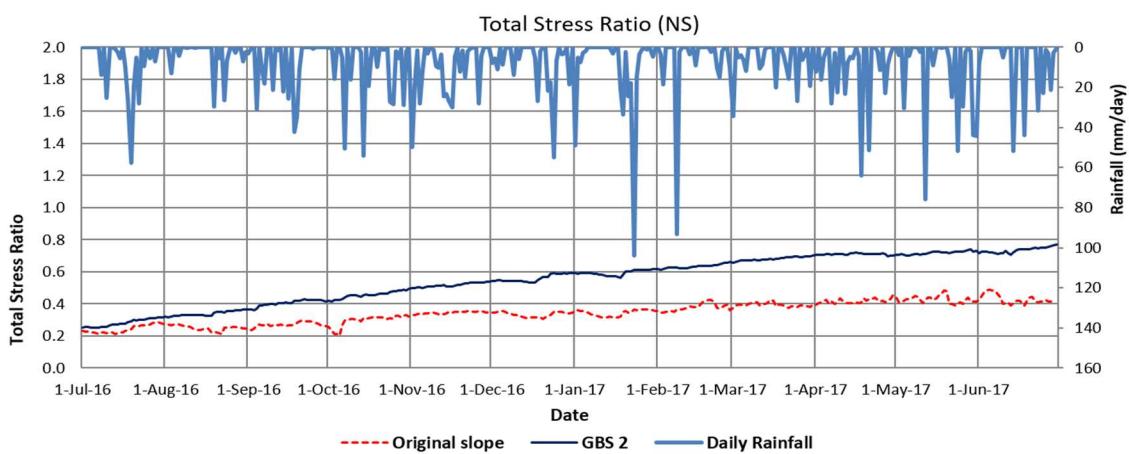
**Figure 51: Total stress ratio in original slope and GBS slope 2**

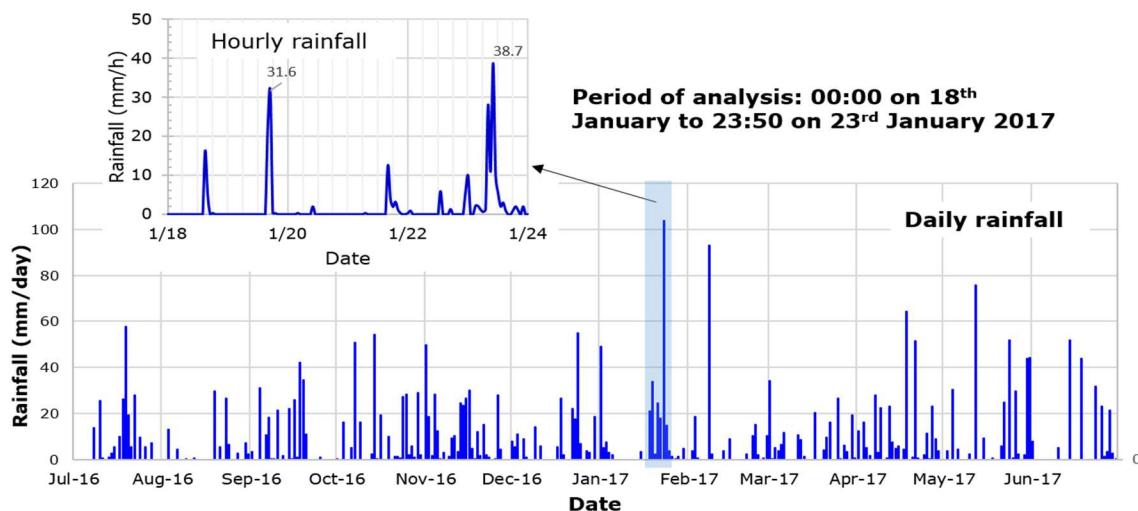
**Figure 52: Flux Boundary condition considered in numerical analysis**

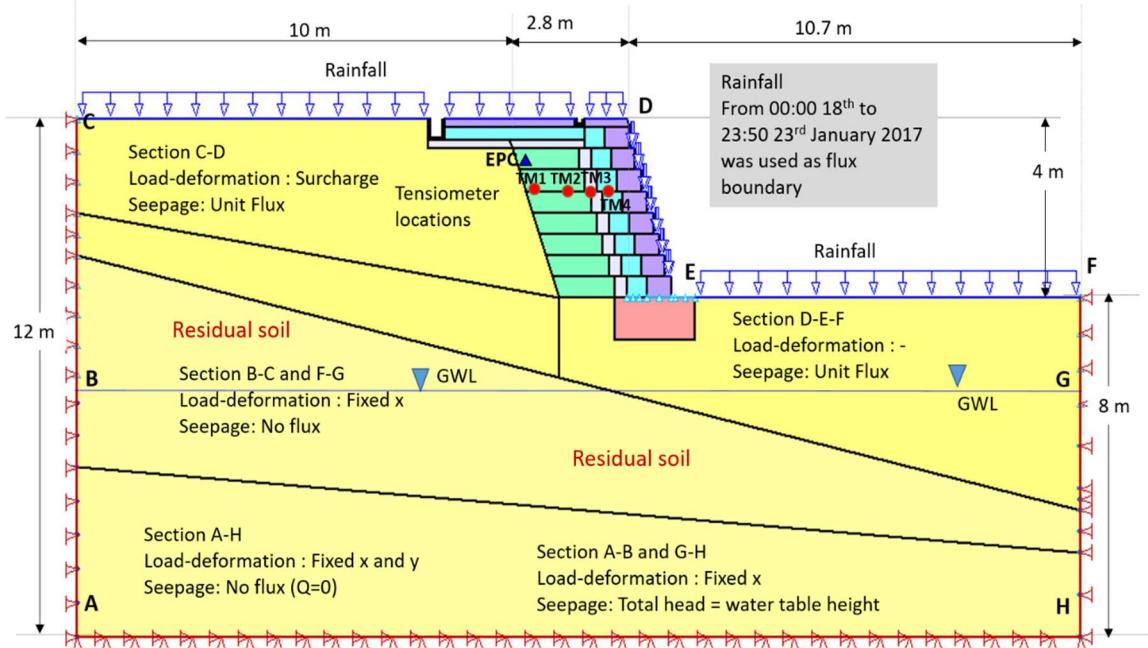
Figure 53: Mesh and boundary conditions for numerical analysis

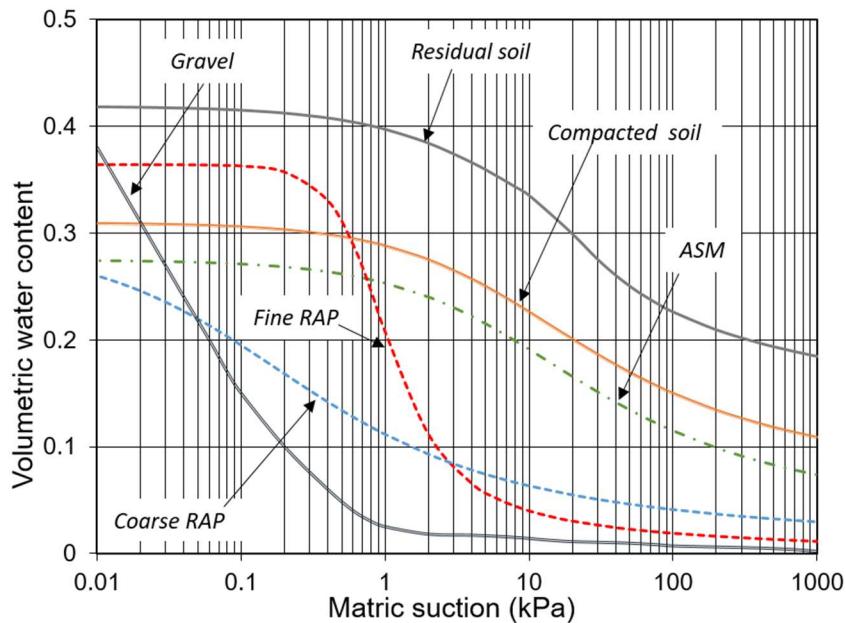
**Figure 54: SWCC used for numerical analysis**

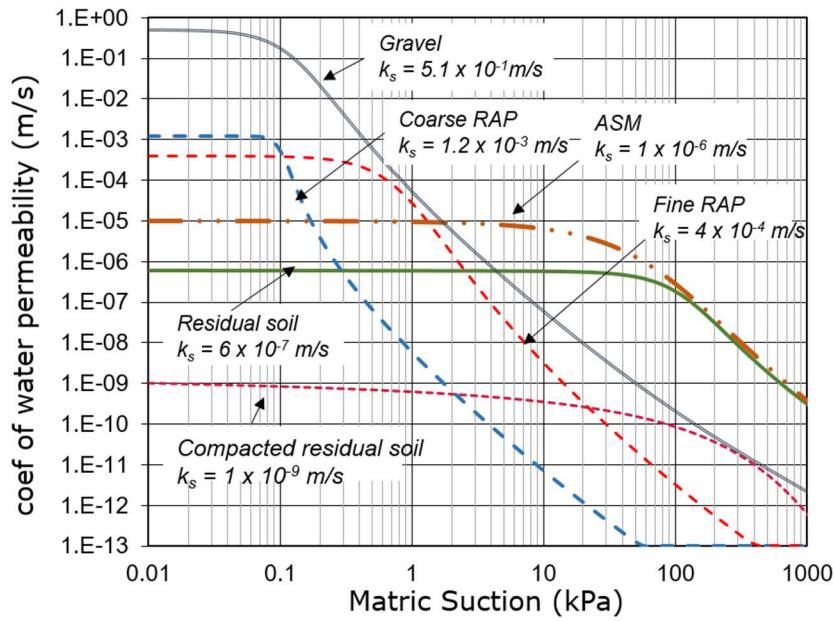
**Figure 55: Permeability function used for numerical analysis**

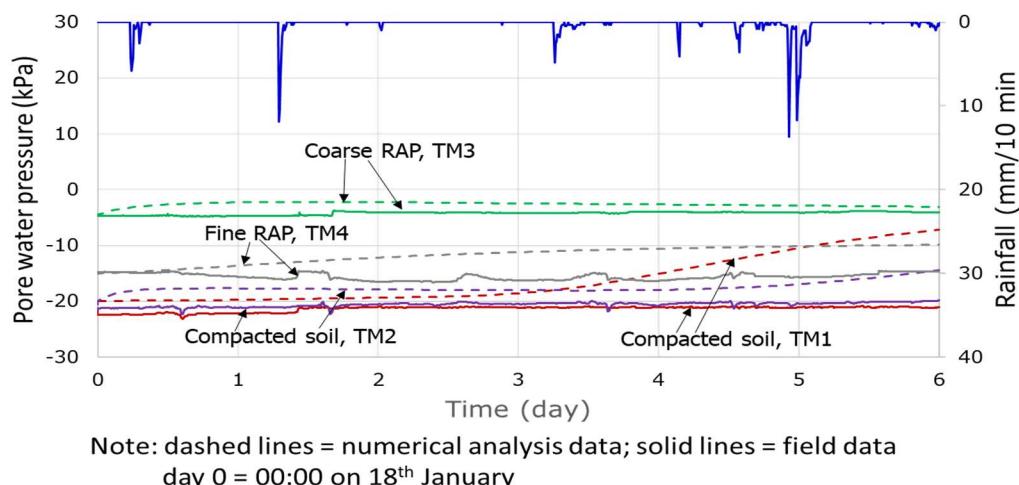
**Figure 56: Pore-water pressure variation in GBS slope 2**

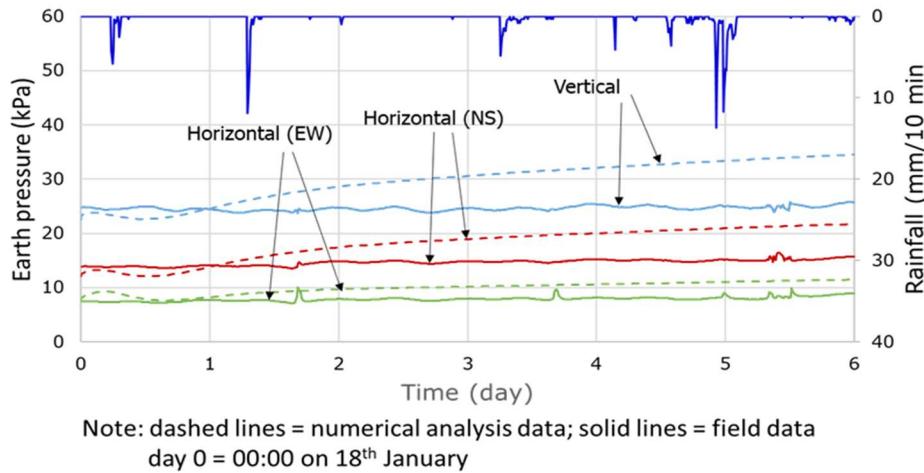
**Figure 57: Vertical and horizontal pressure variation in GBS slope 2**

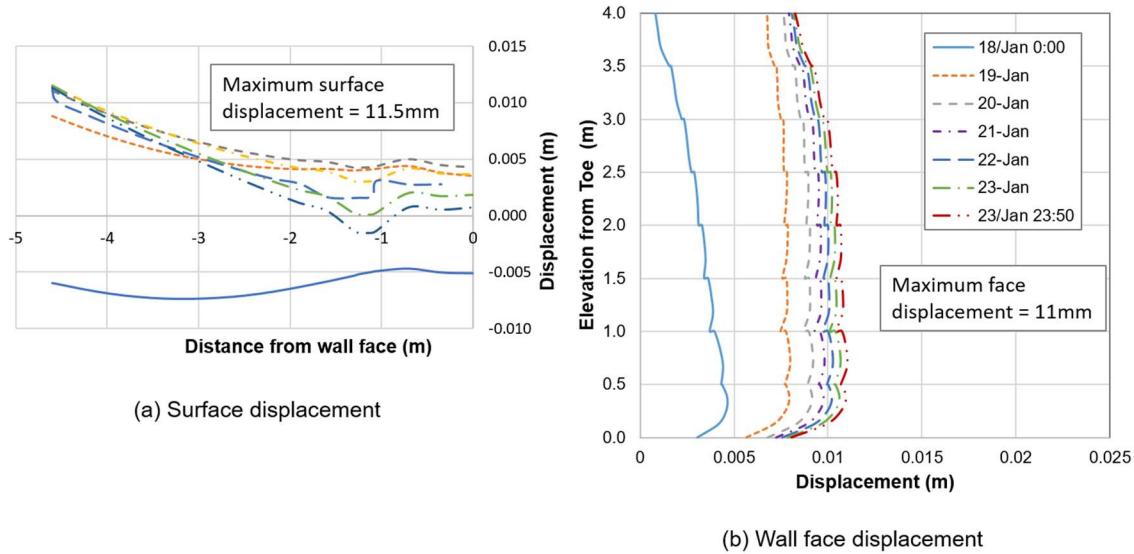
**Figure 58: Displacement of GBS slope 2 due to rainfall infiltration**

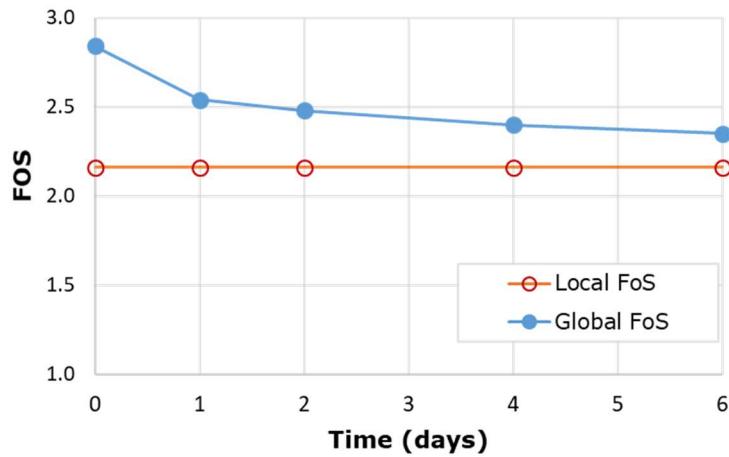
**Figure 59:** Variation of Factor of safety of GBS slope calculated by SLOPE/W

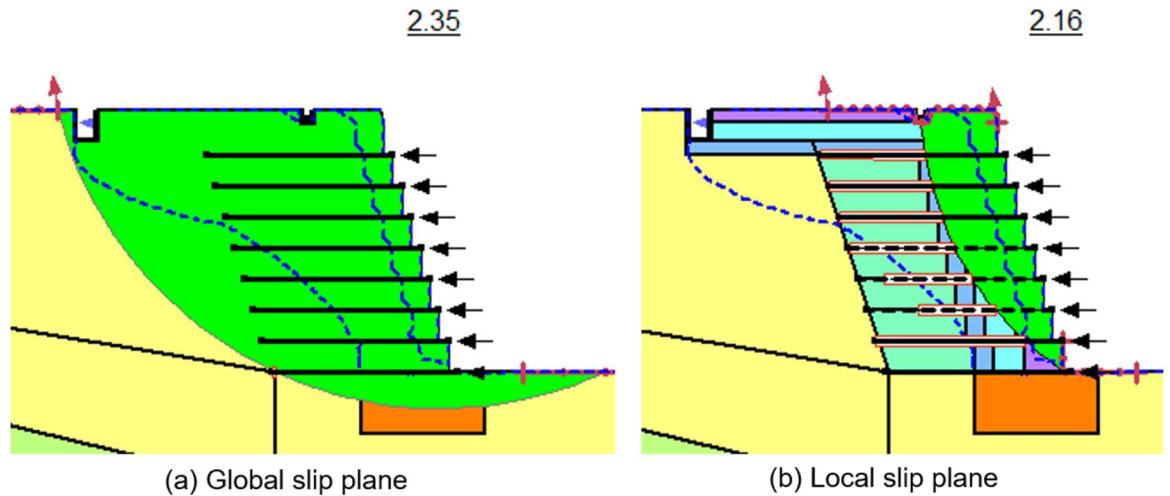
These figures show the slip surfaces and pore water pressure contour on day 6 or at 23:50 on 23<sup>rd</sup> January

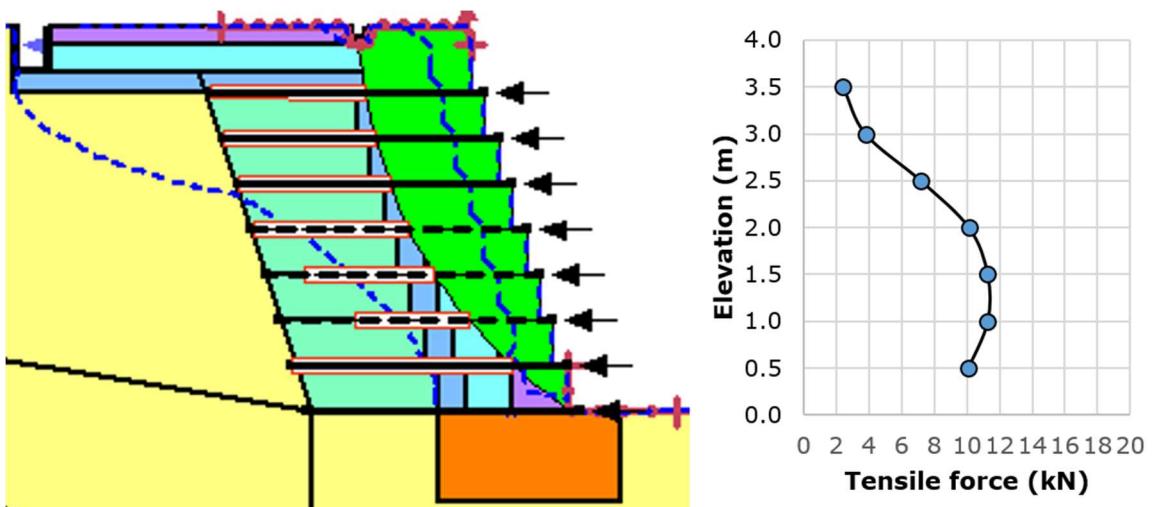
Figure 61: Maximum tensile force generated in each geogrids layer
